THE NECESSITY OF A PLATEAUED CYLINDER WALL FINISH

BRUSH RESEARCH MANUFACTURING CO., INC

A "BRM-STATE-OF-THE-ART" ON CYLINDER-WALL FINISHING

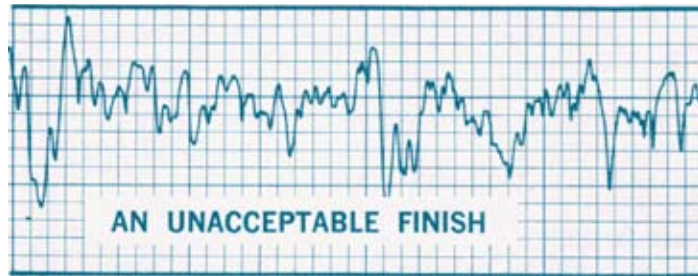
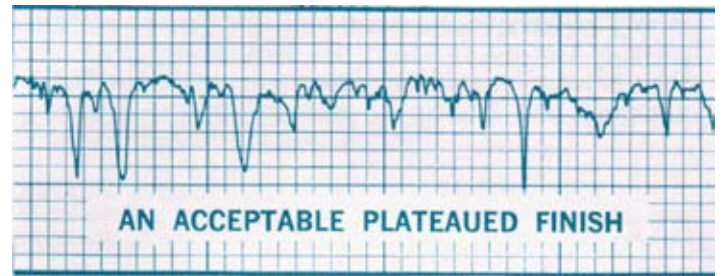
At the bottom of this paragraph you will see two surface finishes that, when read on the direct re-out AA meter, will give you basically the same reading. But the profilometer will indicate that one is a very peaked unacceptable finish and that the other is an acceptable plateaued finish. The plateaued finish will accept the piston rings on a wider more stable bearing surface and will eliminate the necessity for the rings to wear off all of the peaks in its "bedding-in" process. There no longer is any need or any reason to provide or to allow this bedding-in process as a standard 2,000 miles running-in, which punishes the rings.

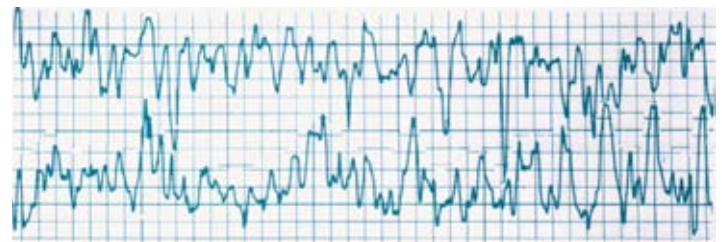
VARIANCES OF PRESSURE ON A BEARING SURFACE DUE TO FINISH

If we have for example an 80% plateaued area then we will have a surface pressure of 625 pounds per square inch. With a 40% plateau the 500 pounds pressure will now increase to 1.250 pounds per square inch.

With a 10% plateaued area, such as we would find in an extremely peaked surface, then the bearing area is 1/10 which increases the pressure of the

contacting surfaces up to 5,000 pounds per square inch.

This is based upon the knowledge that the pressure on the surface is the load divided by the projected bearing area. This additional load caused by a peaky finish is going to have a lot to do with what happens when these two metal surfaces start rubbing together.

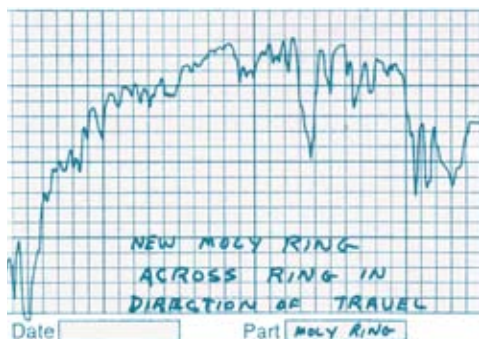
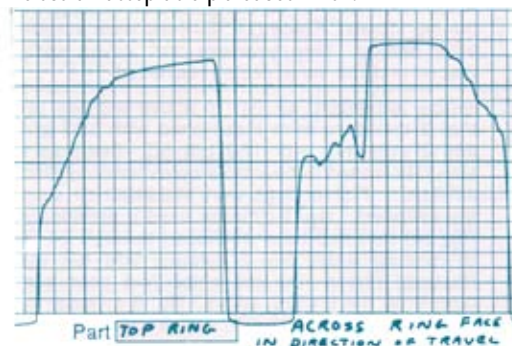
PROFILES ABOVE: On the left is the surface of a new Moly coated ring. On the right is the profile of a new AM top ring after 10 hours of running-in on a very peaky rigid hone finish as reported in the K-C Report (pg 15). Build-up in the center is probably carbon deposit. Wear-factor did plateau the ring as it originally had a thread patterned surface.

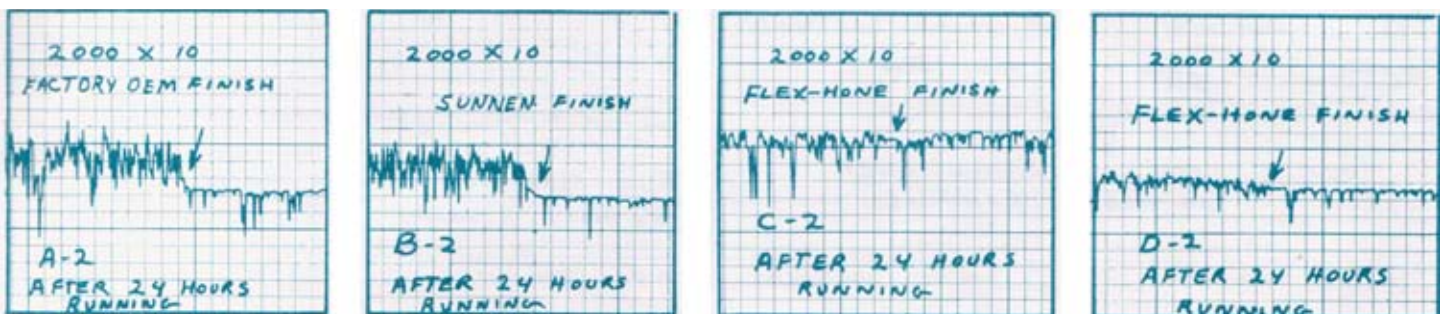
Condensed profiles of cylinder wall finishes for comparison of cylinder wear. Profiles were all taken from the same areas of the #2 cylinder on each test engine. Area of ring travel is the right hand portion of above profiles. Magnification is 2000 times vertical (.00005' / or .00127mm division) and 10 times horizontal (.010' / or .254 mm per division).

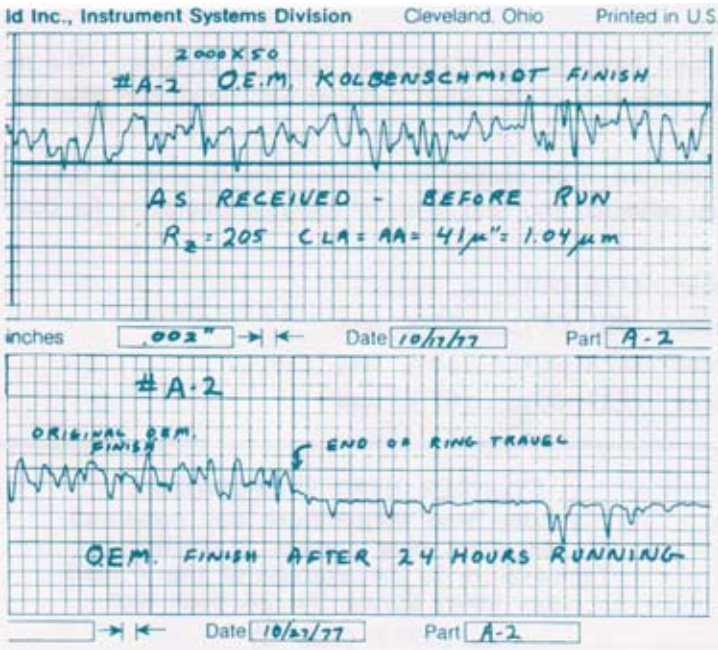
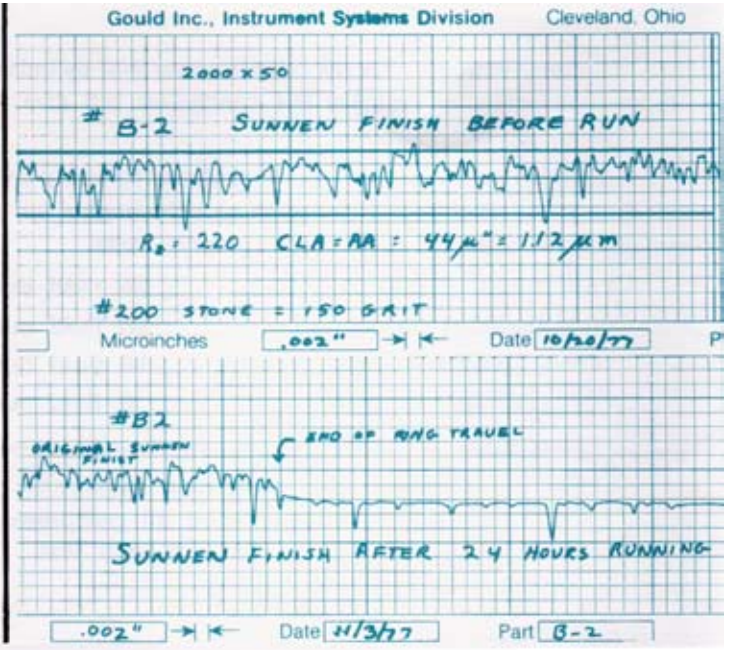
Engine "A" Cylinder #2 showing typical profiles of # O.E.M. finish before and after test run.

Engine "B" Cylinder #2 profiles of Sunnen honed finish before and after test run.

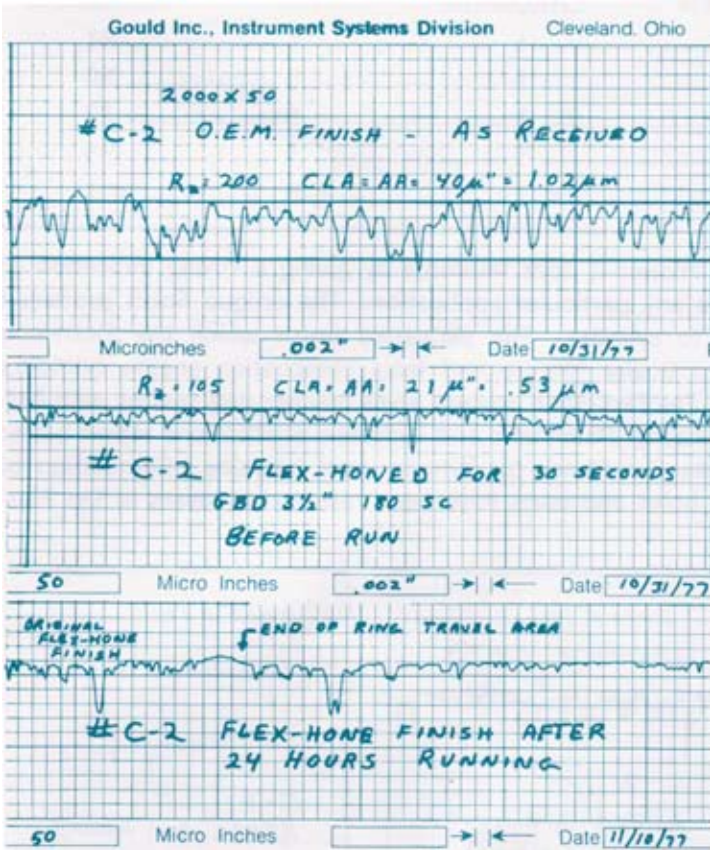
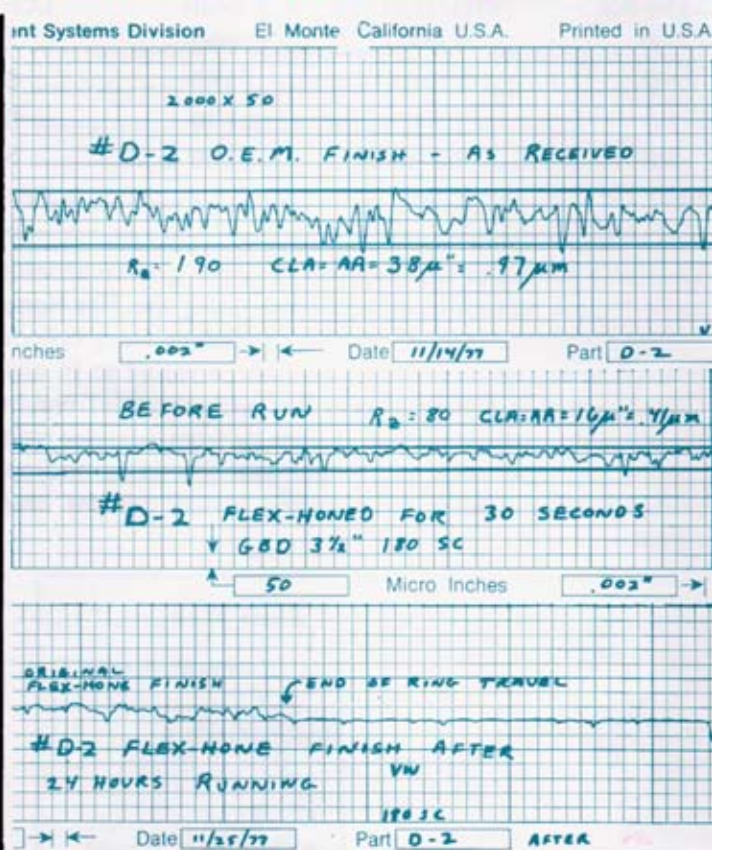
Flex-Honed engines "C" and "D" cylinders from # 2 position, profiles of O.E.M. finish as received, profiles of surface finish after using Flex-Hone GBD away 180 grit for 30 seconds and profiles of Flex-Hone surface finish after 24 hours of running in test engines. Compare "run-in" surface finish in ring travel area of "A" to Flex-Hone finish on C and D final profiles.

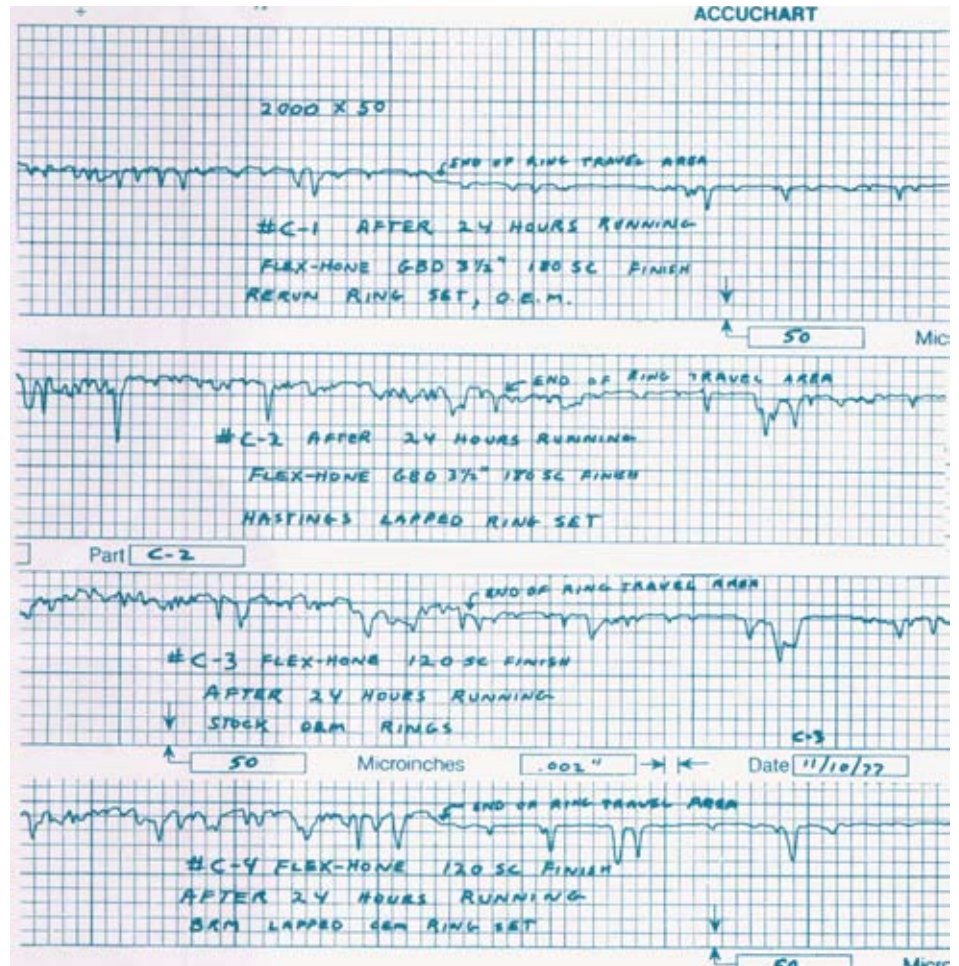
Flex-Honed VW engine "C" profiles of all cylinders after 24 hours of running. Profiles were taken at end of piston ring travel area. Cylinders C-1 and C-2 were 180 grit Flex-Honed before test run. Cylinder C-3 and C-4 were 120 grit Flex-Honed. Specially prepared ring sets were used in test run.

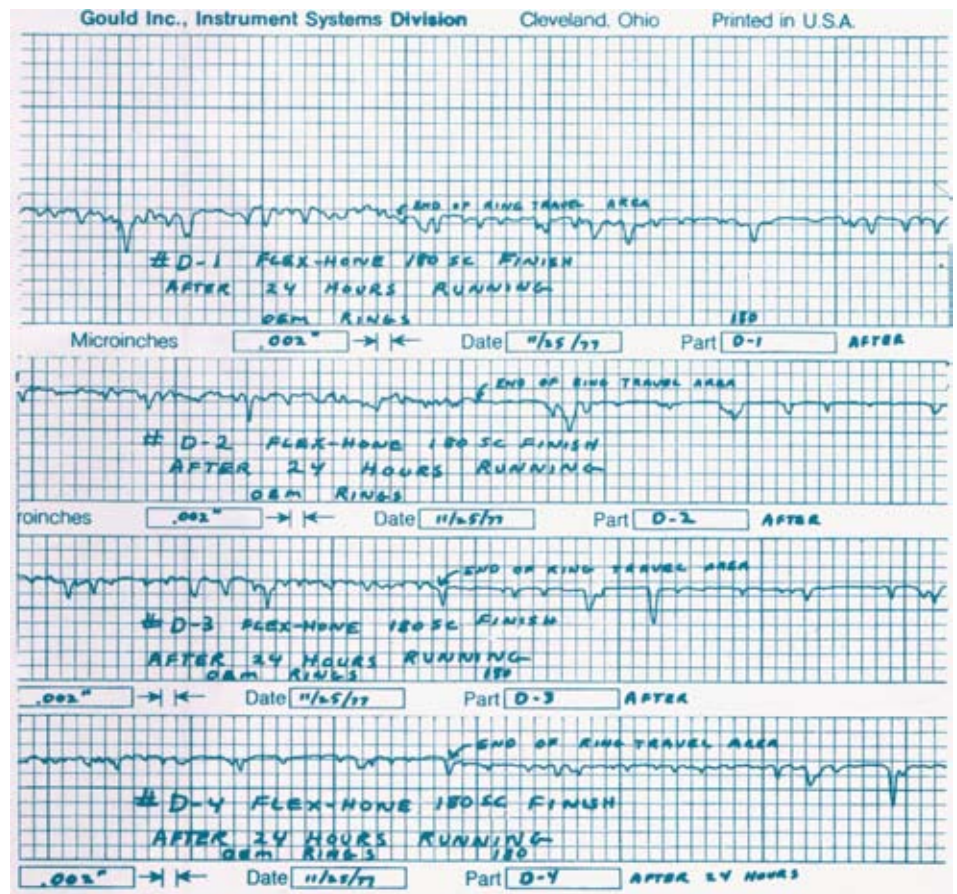
Flex-Honed VW engine "D" profiles of cylinders after 24 hours of running. All cylinders were 180 grit Flex-Honed for 30 seconds before test run.

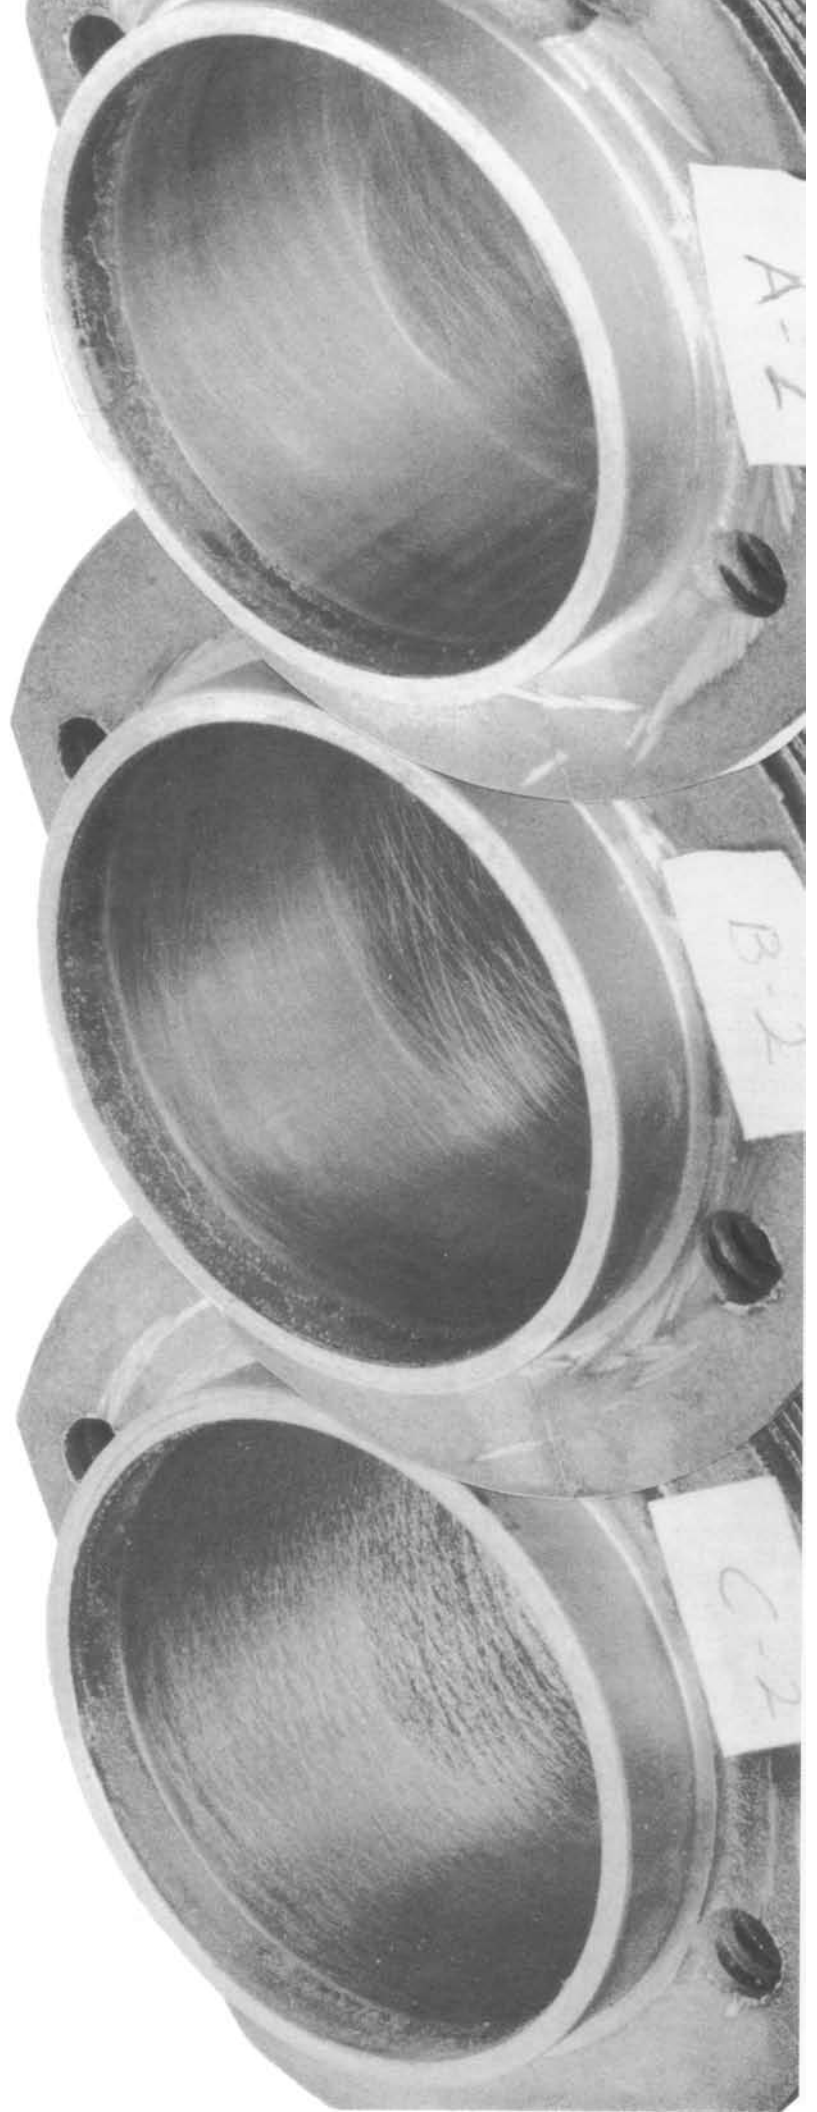
O.E.M. finish after 24 hours of running in engine "A." Cylinder wall had a glazed appearance and many fine vertical scratches.

Sunnen finish after 24 hours of running in engine "B." Finish was similar to above with a glazed appearance in ring travel area and many fine vertical scratches.

FLEX-HONE finish after 24 hours of running in engine "C." Cylinder wall still shows the unique appearance of Flex-Hone finish with cross-hatch clearly visible in entire ring travel area. Surface has a slight matt appearance and "open" look, without any sign of glaze or burnishing.

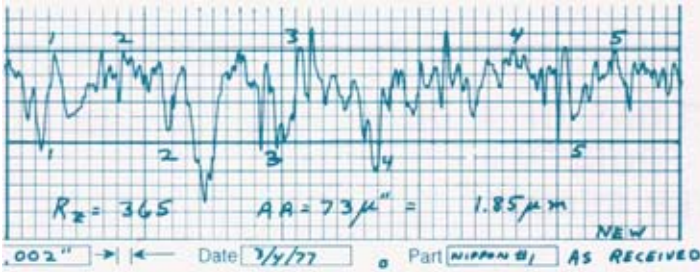
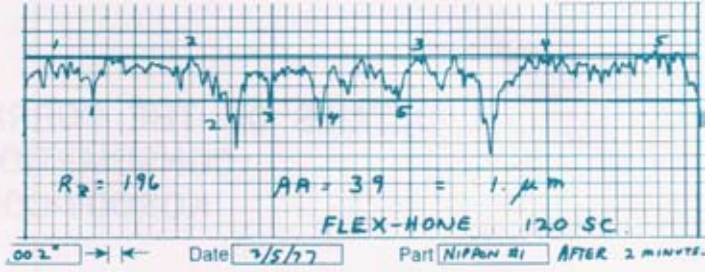
NIPPON #1 CYLINDER:

A new cylinder as received from manufacturer. This was one of six new Nippon liners that were brought to Brush Research by Korody-Colyer because of ring seating problems. This cylinder shows the typical peaky profile of these cylinders as received. This cylinder had an AA finish of $73 \mu m$ ($1.85 \mu m$). After using a Flex-Hone GBD 4 1/2" 120 grit Silicon Carbide for two minutes in the above bore the finish was improved to a semi-plateaued AA finish of $39 \mu m$ ($1 \mu m$). Material removed after two minutes of honing $.00025"$ ($.006 mm$). The cylinder material had a high boron content and difficult to hone as compared to a cast iron engine block.

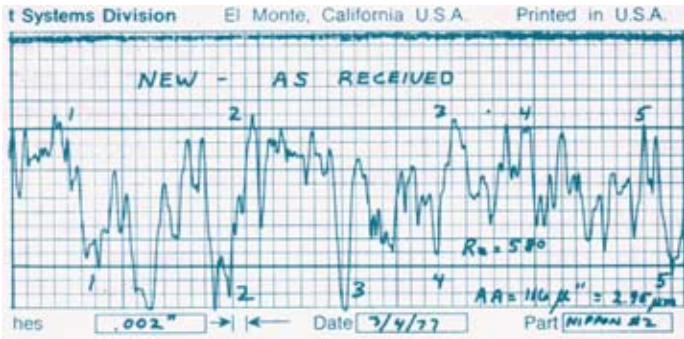
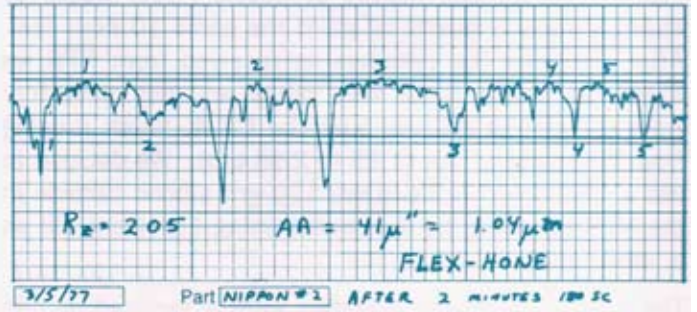
NIPPON #2 CYLINDER:

A new cylinder as received showing the very peaky finish typical of the new Nippon cylinders. This bore had an AA finish of $116 \mu m$ ($2.95 \mu m$). After using a 180 grit Silicon Carbide Flex-Hone for two minutes the finish was improved to a plateaued AA of $41 \mu m$ ($1.04 \mu m$). After an additional two minutes of Flex-Honing the surface finish was not changed much at an M of $42 \mu m$ due to the original rough surface and the hardness of the material being honed.

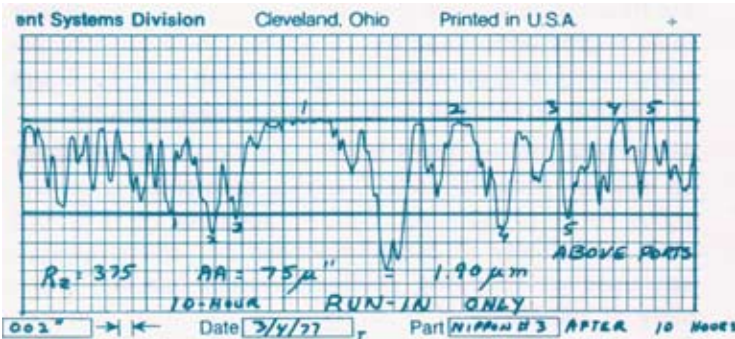
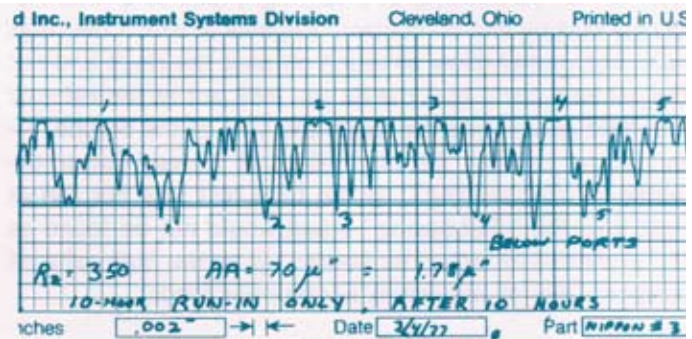
NIPPON #3 CYLINDER:

As received after being run for 10 hours in a V-8 test engine at Korody-Colyer. During the test the engine was reported to have consumed 14 quarts of lubrication oil (typical usage for General Motors or Sealed Power cylinders was stated to be 3 quarts). The area above the ports is subject to combustion pressure and showed considerable ring blow-by as discoloration on the wall surface. The profile of the surface shows very little plateau from the rings and the AA of $75 \mu m$ ($1.90 \mu m$) is still very peaky. The area below the ported area was typical of the finish above the pods with an AA finish of $70 \mu m$ ($1.78 \mu m$).

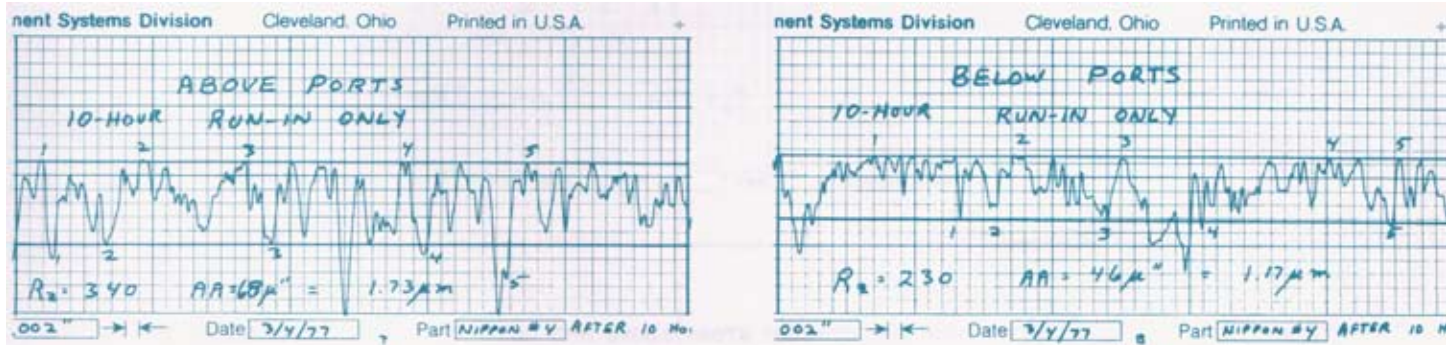
NIPPON #5 CYLINDER:

This cylinder was Flex-Honed for two minutes with the GBD $4 \frac{1}{2}$ " Flex-Hone 120 grit Silicon Carbide using Flex-Hone oil for a lubricant before the 10 hour run-in test at Korody-Colyer. The profiles were taken of the cylinder bore above and below the ported area. Piston ring seating was excellent as the engine consumed only 2 quarts of lubrication oil during the 10 hour test. The plateau profile is evident in both ring travel areas. Deep scratches from the original manufacturing are still evident as valleys much deeper than the regular profile pattern.

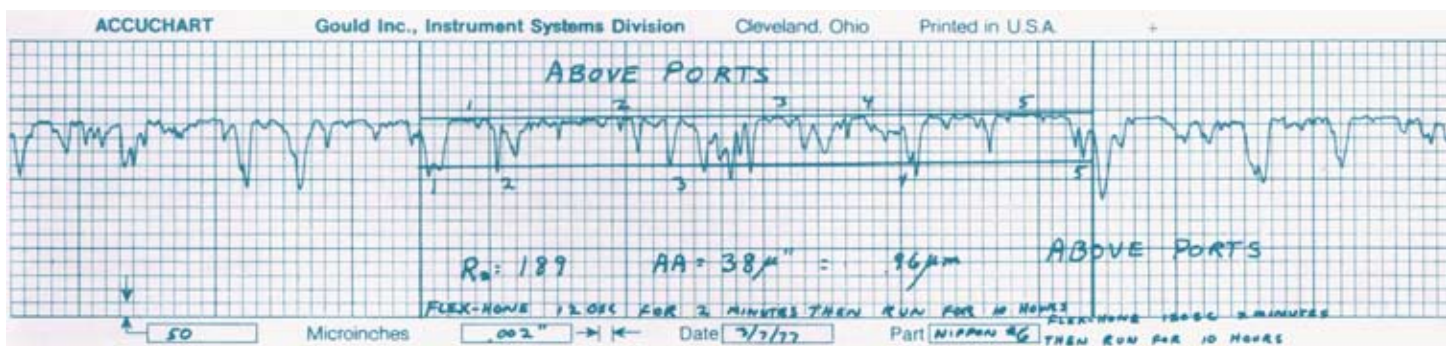
NIPPON #7 & #8 CYLINDERS:

Profiles of the cylinder areas above and below the intake ports shows the excellent plateau created after running for 10 hours on a Flex-Honed surface. The cylinders were Flex-Honed for two minutes before run in a test engine. The original Flex-Hone finish is visible on the left hand portion of the profile of cylinder #8. Approximately 75 millionths of an inch (.001905 mm) of stock was removed during ring seating. During the 10 hour test the engine consumed 2 quarts of lubrication oil (typical usage during a 10 hour test is about 3 quarts when using either General Motors or Sealed Power cylinders in the same engine.)

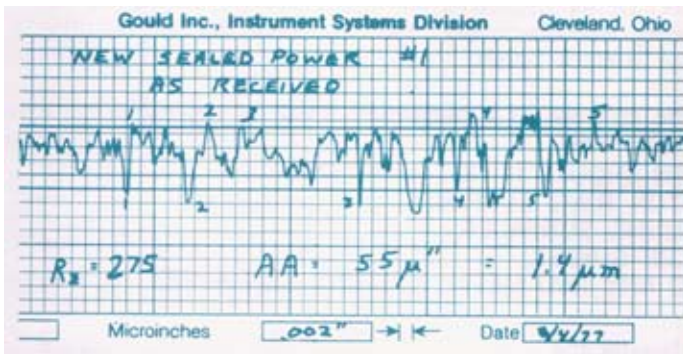
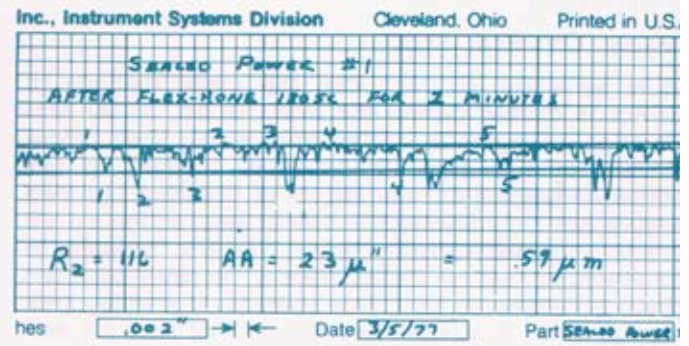
SEALED POWER #1:

A new cylinder as received from Sealed Power with a consistent and uniform AA finish of 55 μ" (1.4 um) throughout the bore. After Flex-Honing for two minutes with 180 grit Silicon Carbide the surface was improved to a 23 μ" (.59 um) plateau profile typical of the Flex-Hone. Stock removal after two minutes .0001-.00254 mm).

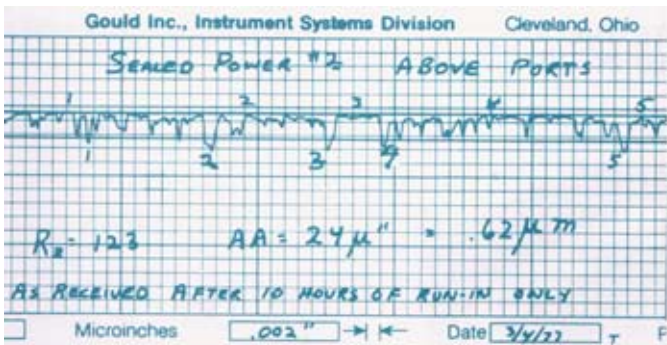
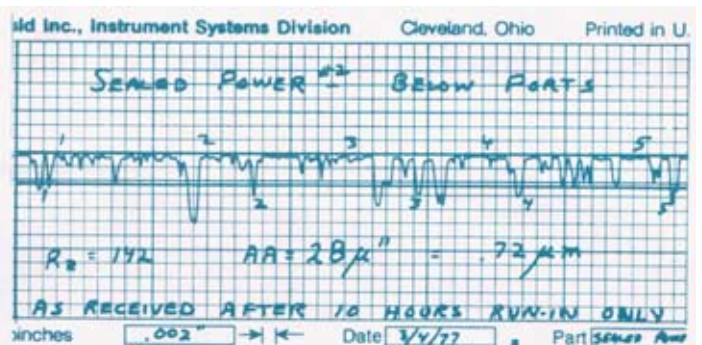
SEALED POWER #2:

A Sealed Power cylinder received after having been run for 10 hours in a test engine. The finish is an excellent plateau profile in the areas above and below the intake ports. The AA 24 μ" (.62 um) finish above the ports is virtually identical to the Flex-Hone finish created in the new Sealed Power cylinder #1 above. The Flex-Hone accomplished in two minutes the same profile finish that was produced by 10 hours of running in an engine under load. The area below the ports had an AA of 28 μ" (.72 um) with a similar plateau profile finish.

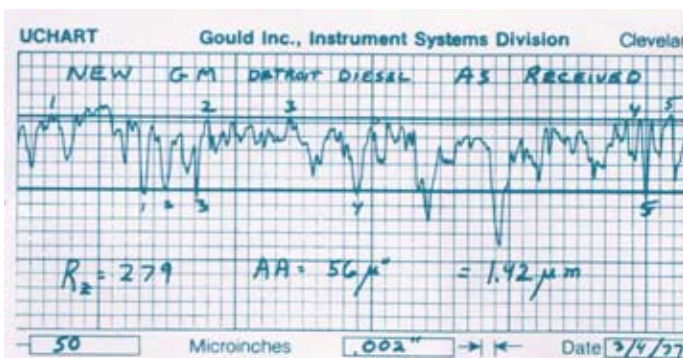
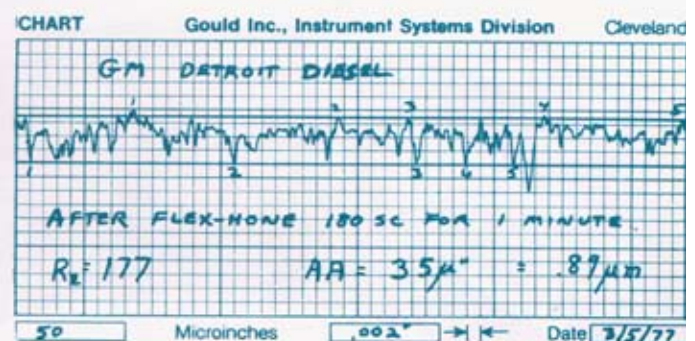
GM #1 CYLINDER:

Profile of a new cylinder as received from General Motors showing a finish of AA 56 μ" (1.42um). Finish is consistent and uniform through out bore. After Flex-Honing for one minute with 180 grit Silicon Carbide the finish was improved to an AA of 35 μ" (.89 um) with an improvement in plateau profile.

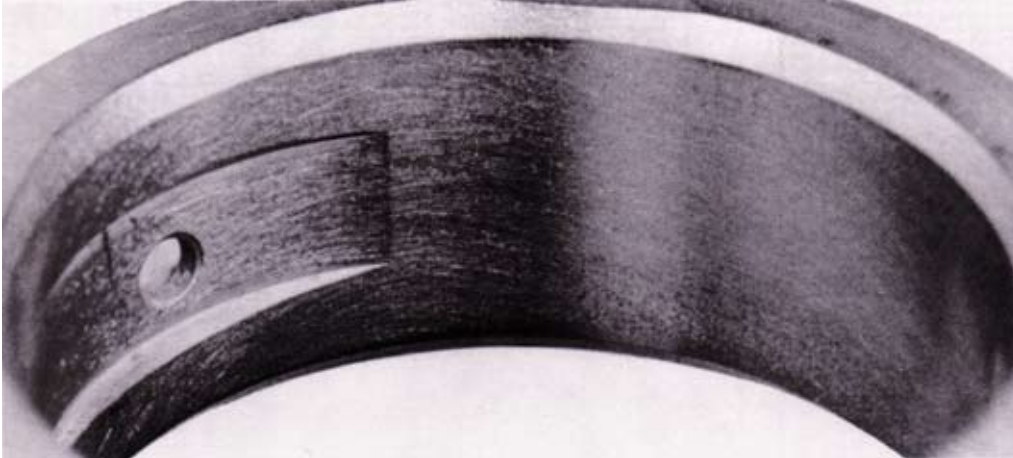
Bearing from "C" engine No. 2 cylinder taken after 24 hour run. All "C" Engine bearings were Flex- Honed first for 12 strokes with 320 AO.

Notice absence of scoring and wear and appearance of original Flex-Hone finish.

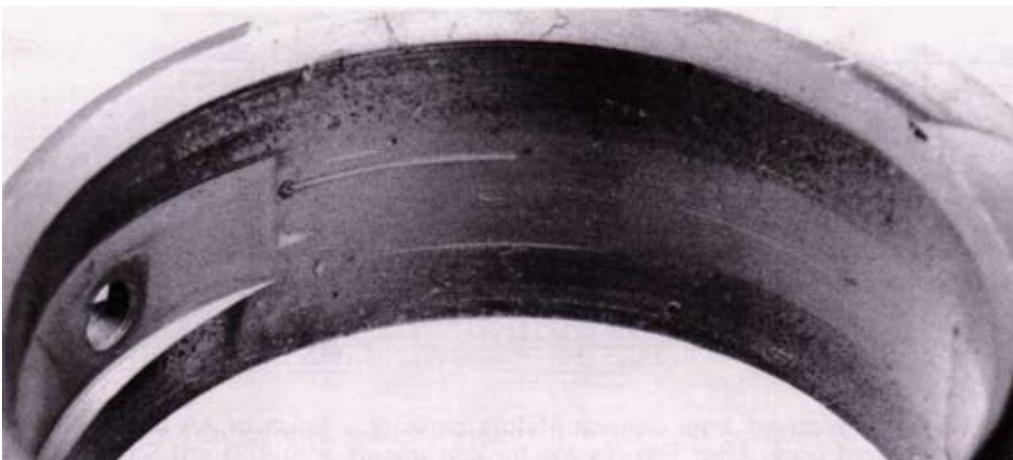
Bearing from No. 2 cylinder "A" engine after 24 hour run. An OEM new bearing such as were used in all the trials. Similar effects will be noted on all bearings as shown on the next page.

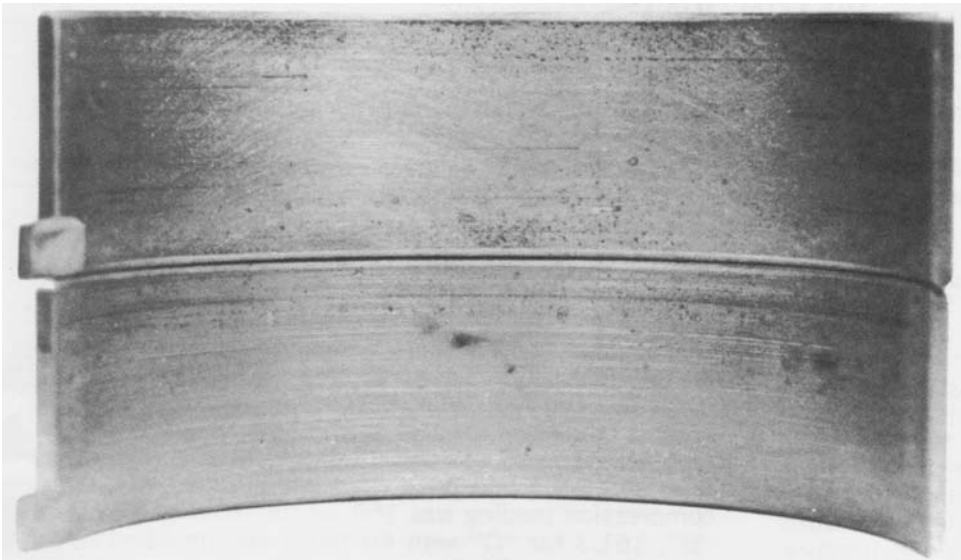
Flex-Honed Finish is easy to distinguish. Both from No. 2 cylinder assembly after the 24 hour run. "C" test on top and "A" below.

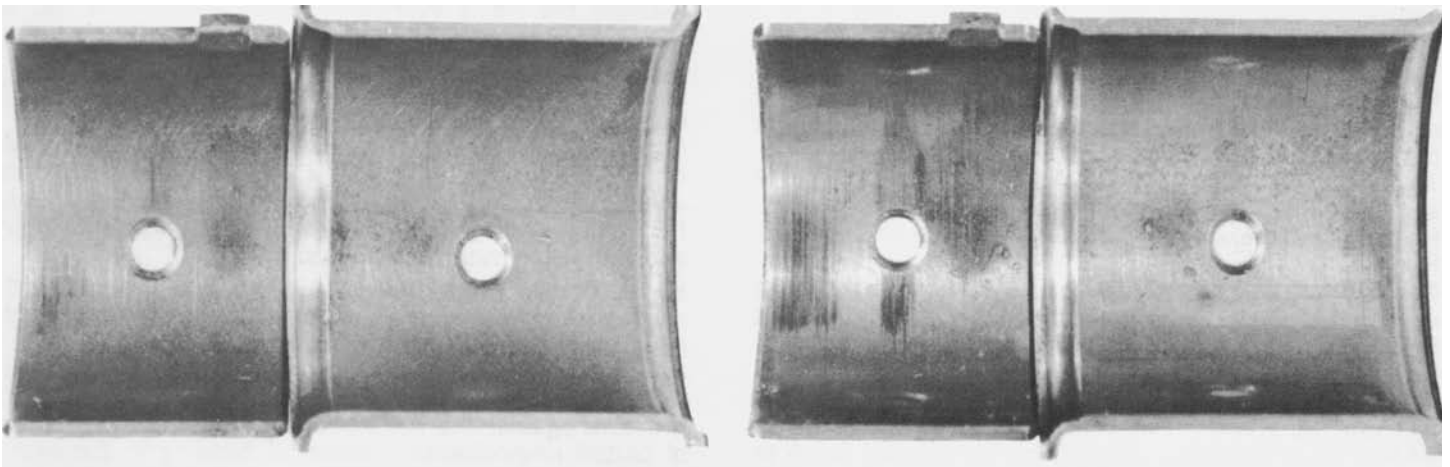
Original Flex-Honed Finish looks the same as before the 24 hour run. "C" No. 2.

O.E.M. set from "A" No. 2. The appearance does not leave much choice, does it?

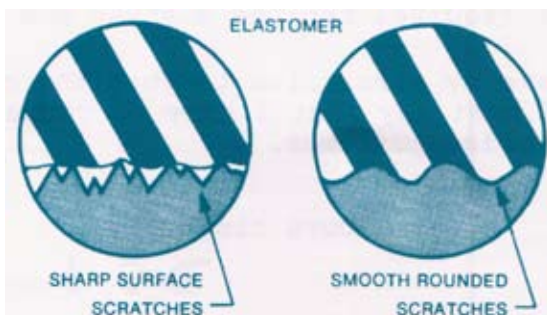
If surface scratches (peaks and valleys) are sharp, elastomer may not be able to conform to the irregularities, permitting leakage. Sharp scratches also cause accelerated abrasion wear. Elastomer easily conforms to surface with smooth, rounded peaks and valleys.

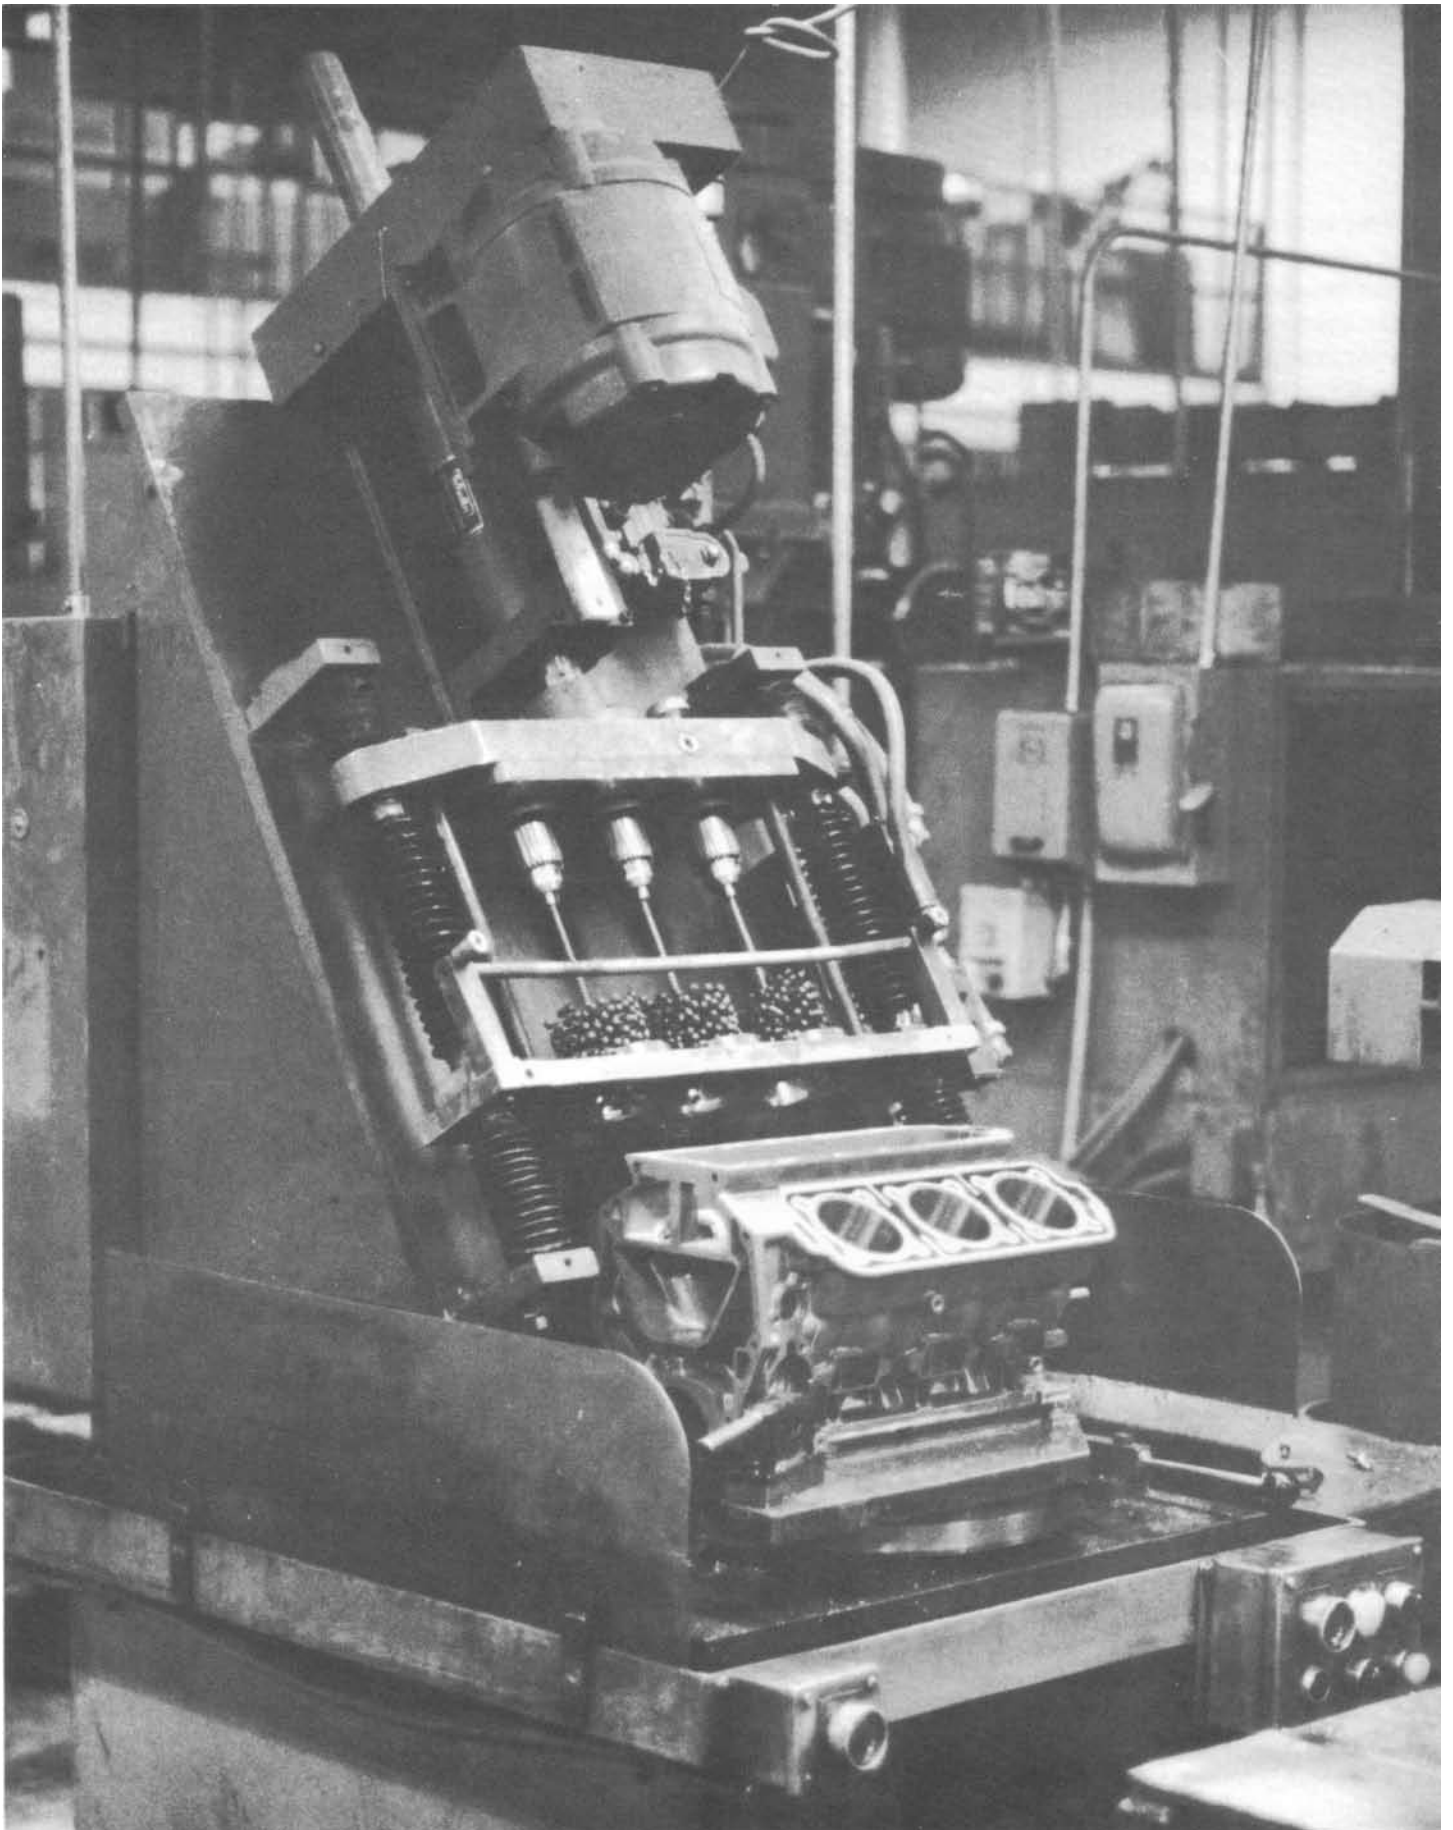
FLEX-HONE MACHINE DEVELOPED FOR PRODUCTION HONING ON NEW ENGINES

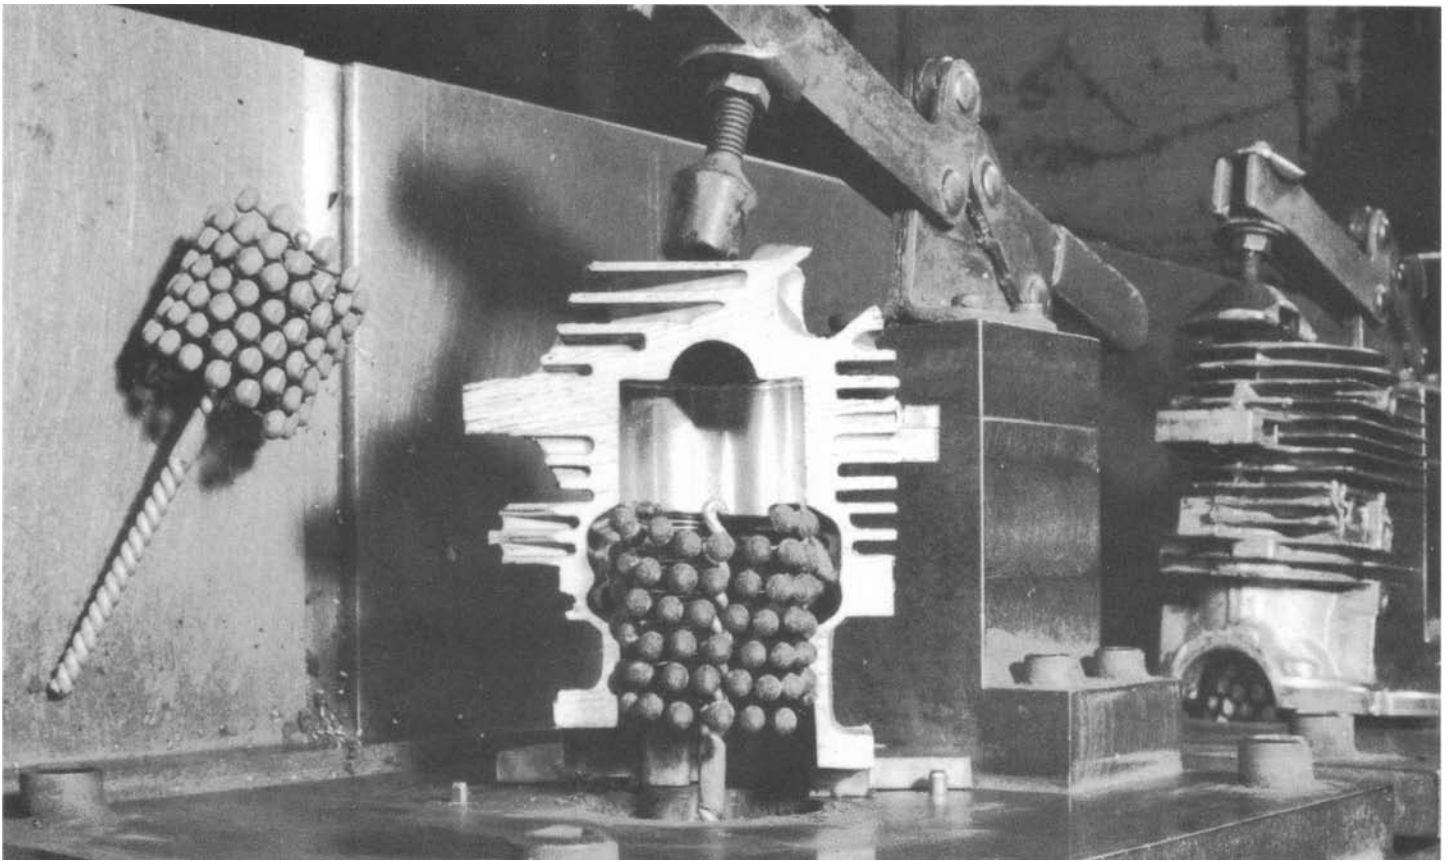
MACHINE DEVELOPED FOR FLEX-HONE USE ON NEW 2-CYCLE ENGINES. HOLDING FIXTURE LOCATES CYLINDER ON DOWEL PINS AT BASE FOR ALIGNMENT WITH FLEX-HONE. POWER STROKING AND ROTATION ARE AUTOMATICALLY CONTROLLED THROUGH FIXTURE BASE.

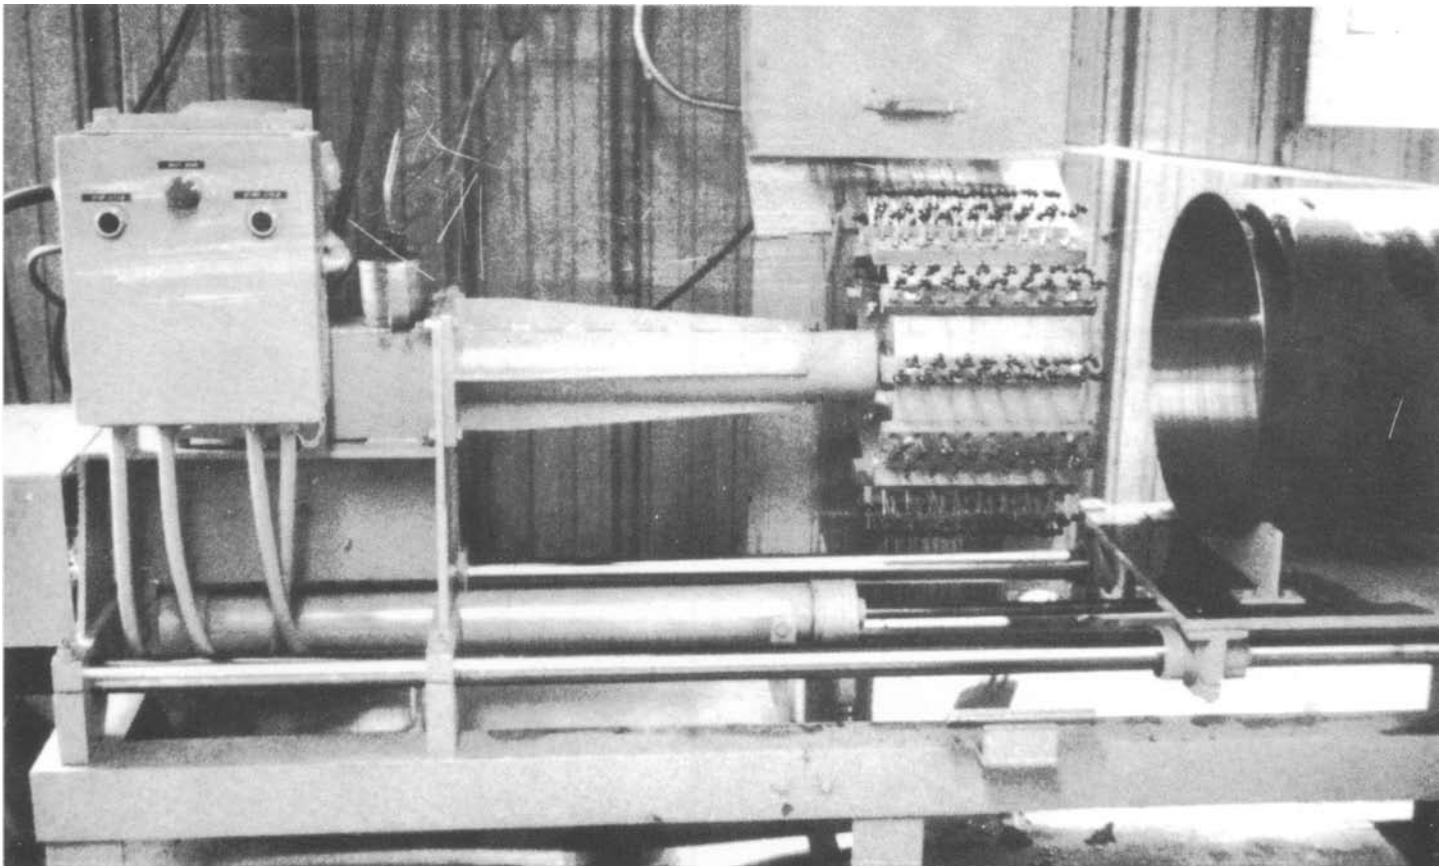
MACHINE DEVELOPED FOR PRODUCTION HONING OF 12" TO 20" (305 TO 508 MM) HYDRAULIC CYLINDER BORES USING GBDX FLEX-HONE
