A STUDY OF A CYLINDER WALL MICRO-STRUCTURE

BRUSH RESEARCH MANUFACTURING CO., INC.

EVOLUTION OF A STUDY IN THE MICRO-FINISHING OF CYLINDER WALLS

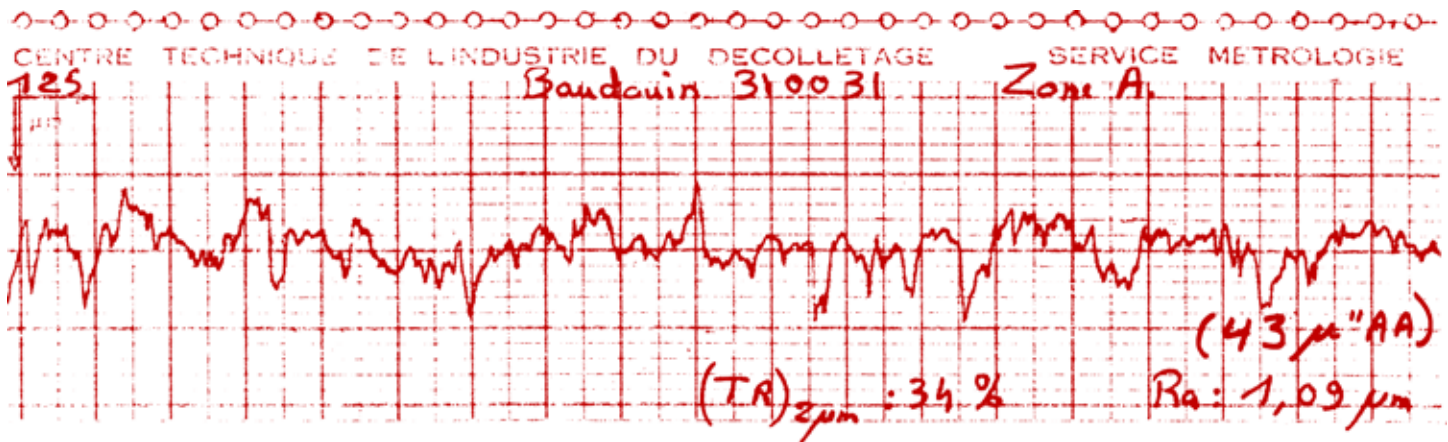
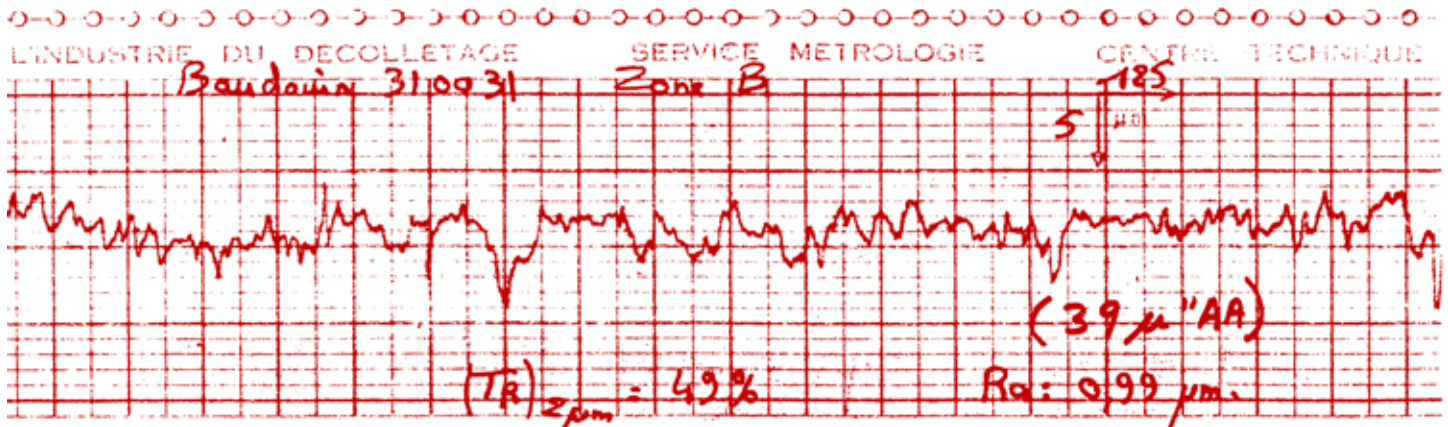
Zone A and Zone B represent an area approximately 5 CM in from the top and bottom of the cylinder liner. The above show the profile in the As Received condition. A.E.F. said they had been rigid normal honed. Finish top was $Ra:1.09$ and bottom $Ra:0.99$. PLATEAUED AREA 34% AND 49%

Baudouin asked A.E.F. to Flex-Hone all liners before final anti-rust coating and delivery to eliminate the problem of doing the Flex-Hone operation after receipt. These normal liners are shown in the following profiles, labeled No. 310031, before and after the Flex-Hone Process.

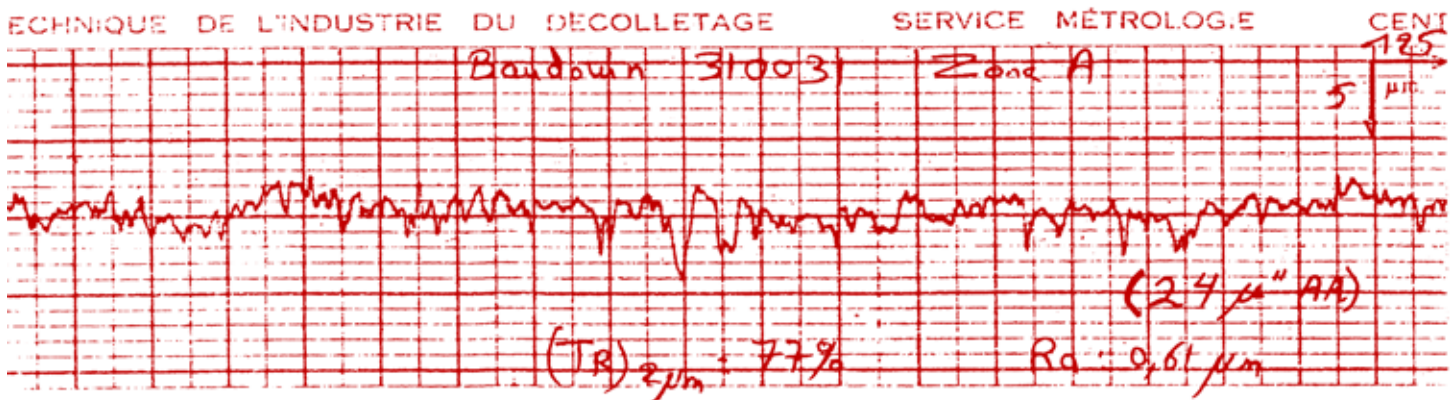
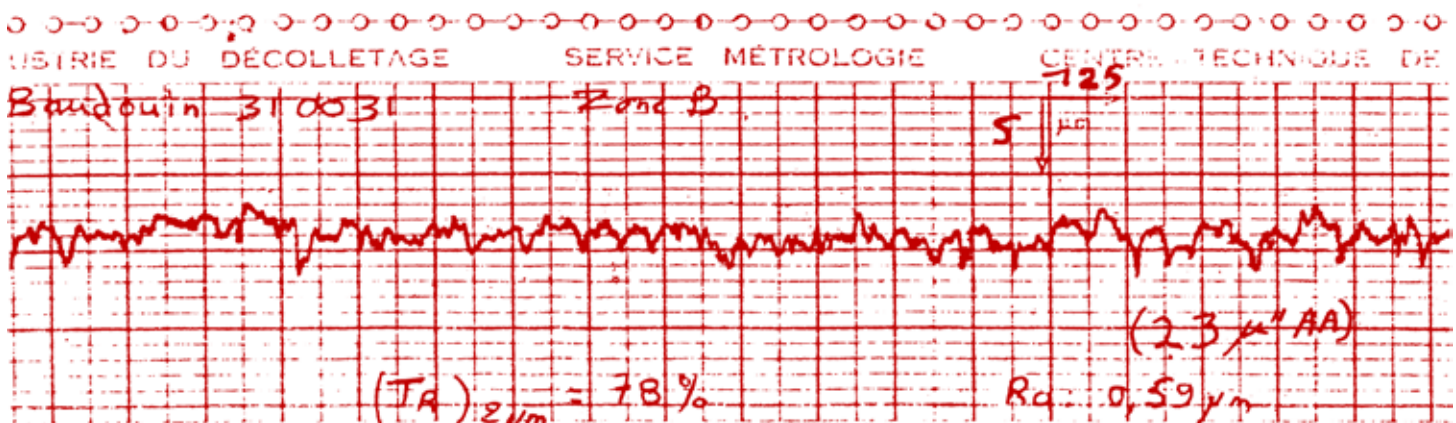
The above two profiles represent the same areas but have been FLEX-HONED with an 80 grain for 60 seconds. Finish has been refined to $Ra:0.61$ and $Ra:0.59$ and the PLATEAUED AREA 77% and 78%.

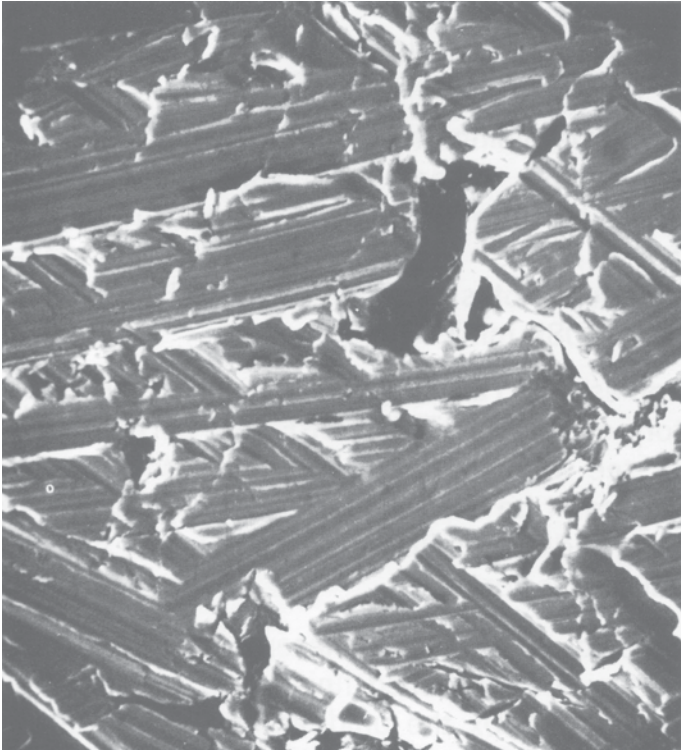
No 6 X1000 AE PLATEAU

Two more SEM photos of Liner 30202 with the 1000 magnification.

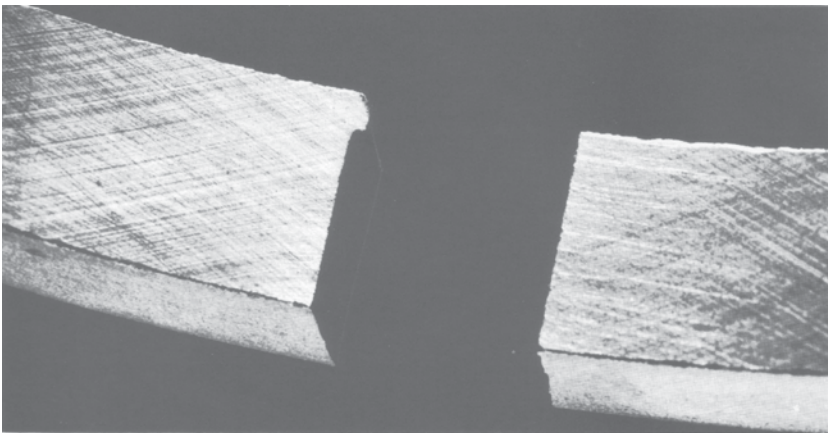
The Baudouin Liner as supplied by A.E.F., Plateau-Rigid Honed Finish. Liner was sectionalized and shows the piece removed for the SEM photo-graphs.

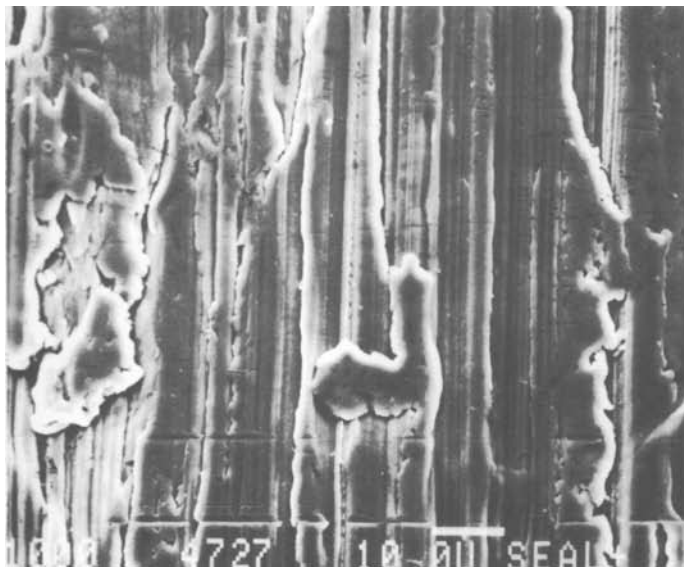
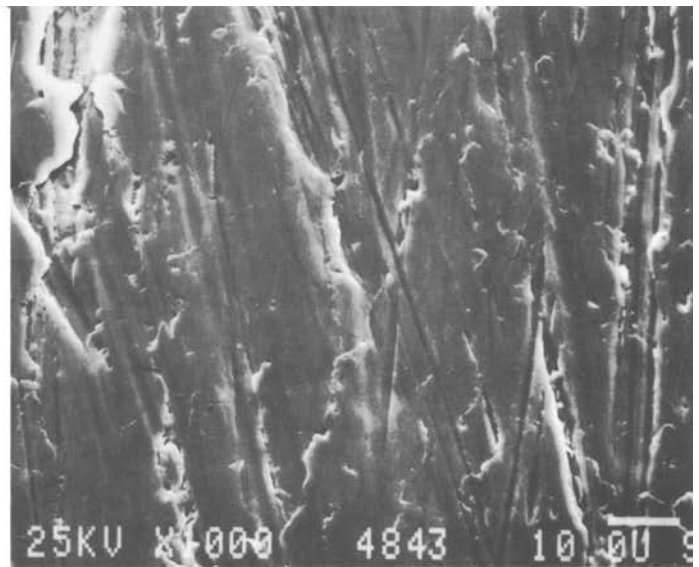
Off the subject of this booklet, we would like to present a small sample of some developmental work in progress on O.D. Finishing of shafts with the Flex-Hone Process. These two SEM photos were taken of a C-1045 ground and polished steel shaft in the before and after Flex-Hone conditions.

Continuing on the consideration of Co-Acting Metals-the two fields of motion and rest-can you visualize the As Is finish rotating at high speed under pressure on a sliding bearing (including journals, thrust and guide bearings), and the attempt to keep these two metals separated by lubricant, a liquid or a gas? A comprehensive study is to be presented at a later date.

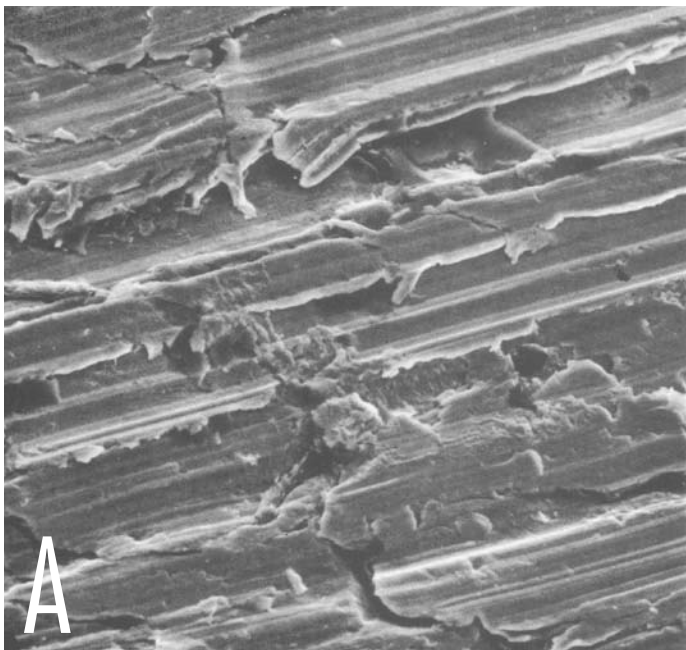
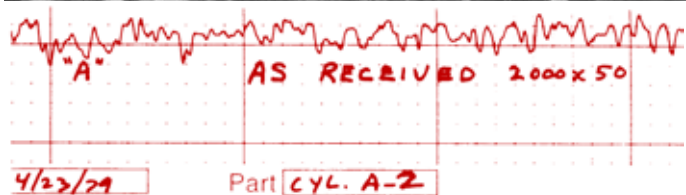
AS RECEIVED, PRODUCTION RIGID HONED, "A" photo taken at 1000x. Unidirectional cut pattern from hone operation. Torn, jagged, folded and smeared metal on surface. Pieces of smeared metal loosely adhered to surface. 20 to 25 μ " finish. Peak saw tooth appearance to profile. #A-2 cylinder.

Cylinder	Condition	Grit & Type	Honing Time In Seconds	Finish AA μ''	Finish μm	Profile Characteristics	SEM Photos
A-2	As Received	—	—	20 - 25	.51 - .63	Peak saw-tooth	A
A-2	Flex-Honed	80 SC	30	30 - 40	.76 - 1.02	Peak semi- plateau	C
A-2	Flex-Honed	120 SC	30	20 - 25	.51 - .63	Semi- plateau	E
A-3	As Received	—	—	20 - 25	.51 - .63	Saw- tooth	G H
A-3	Flex-Honed	80 SC	30	30 - 40	.76 - 1.02	Peak semi- plateau	I J
A-3	Flex-Honed	120 SC	30	20 - 25	.51 - .63	Semi- plateau	K L
A-3	Flex-Honed	180 SC	30	20 - 25	.51 - .63	Semi- plateau	M N
A-6	As Received	—	—	20 - 25	.51 - .63	Peak saw-tooth	O P
A-6	Flex-Honed	180 SC	30	20 - 25	.51 - .63	Semi- plateau	Q R
A-6	Flex-Honed	240 SC	30	12 - 18	.30 - .46	Semi- plateau	S T
A-6	Flex-Honed	320 SC	30	7 - 10	.18 - .25	Semi- plateau	U V
B-1	As Received	—	—	40 - 50	1.02 - 1.27	Very Peak	W
B-1	Flex-Honed	180 SC	30	20 - 25	.51 - .63	Semi- plateau	Y
B-2	As Received	—	—	25 - 35	.63 - .89	Very Peak	A A

The cut, torn and folded-over metal that is quite evident on the surface. This is what sometimes is referred to as the "Deformed Layer" or the "Stress Layer", or "the Plastically Deformed Surface Layer", all of which is different from the basic structure of the metal. The surface should fully represent the microstructure as it existed in the metal before working. You will note that the Flex-Hone Process has removed the fragmented, damaged, deformed slip bands and in the removal of the common cut, torn and folded metal has opened up the surface structure to a condition that will allow oil retention, reduce friction and abrasive wear on the rings and further damage to the wall surface. This also allows the free graphite (provided that particles have not been torn out by the boring tool or the rigid hone) to appear on the surface to aid in the important role of adding to the lubrication. It is also possible that any hardened martensitic layers may also be removed to assist in ring seating and to cut down excessive ring wear and ring surface configurations. With such surfaces as the Flex-Hone Surface now being possible, then perhaps it may no longer be necessary for piston rings to have the original heavy peaky finish for mutual attrition.

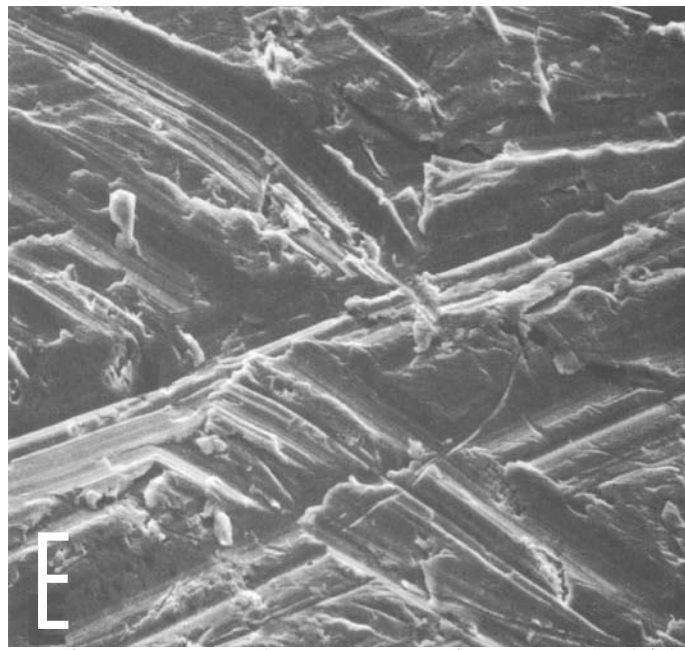
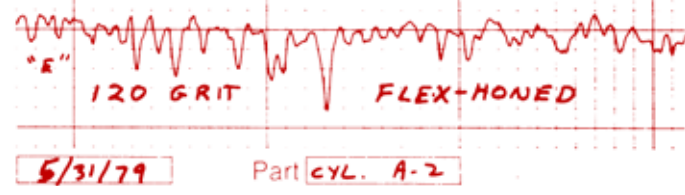
AFTER FLEX-HONE, 120 grit silicon carbide, "E" photo at 1000x. Uniform cross-hatch finish. Most of torn, folded and smeared metal removed. Profiles show good semi-plateaued finish. Surface has clean open appearance. 20 to 25 μ " finish. Section of #A-2 cylinder.

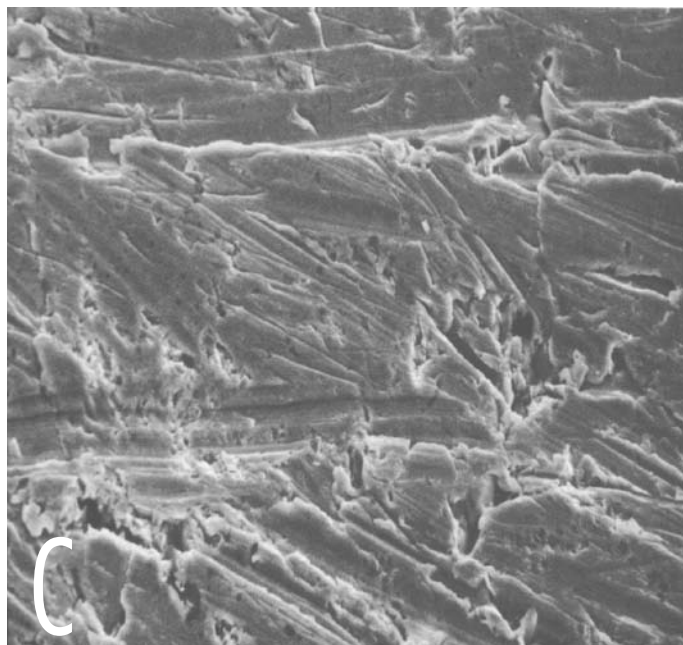
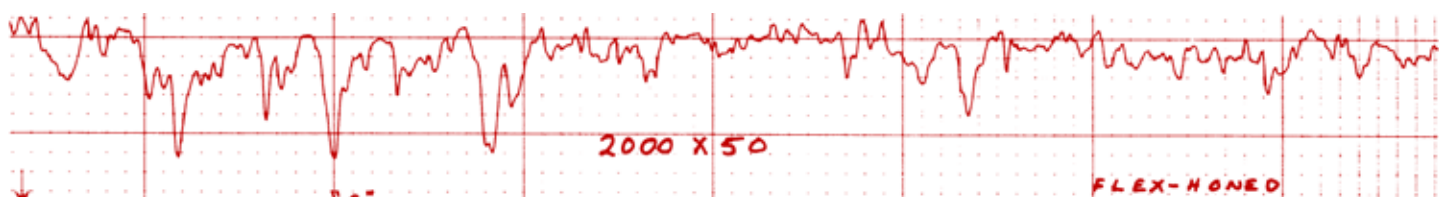
AFTER FLEX-HONE, 80 grit silicon carbide, "C" photo at 1000x. Uniform cross-hatch pattern. Most of torn and folded metal removed. Profile shows some what peaky semi-plateau finish. Profile also reveals that some of original boring operation grooves were opened up by the Flex-Hone operation (deeper grooves on left hand side of profile. 30 to 40 μ " (.76 to 1.02 μ m) finish. Section of #A-2 cylinder.

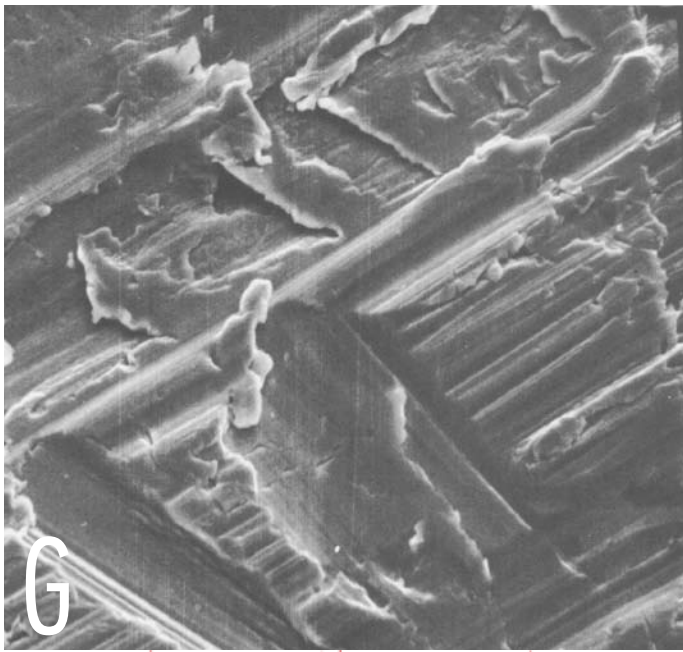
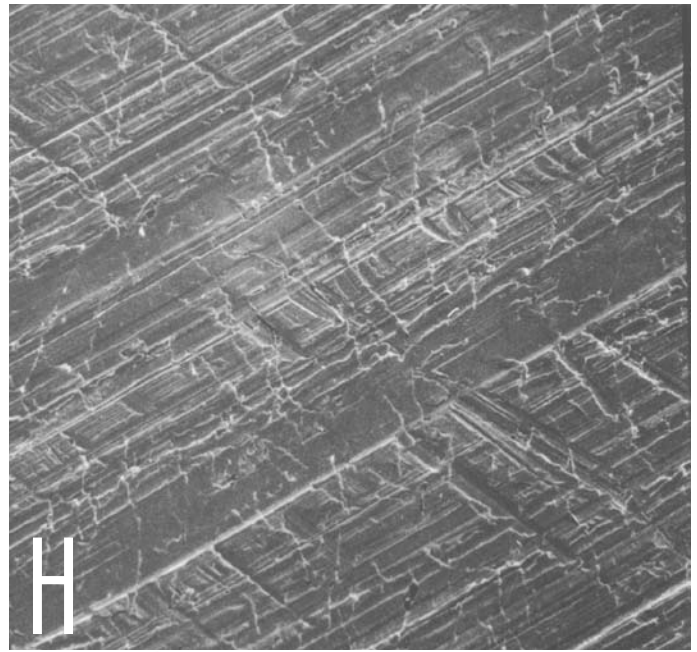
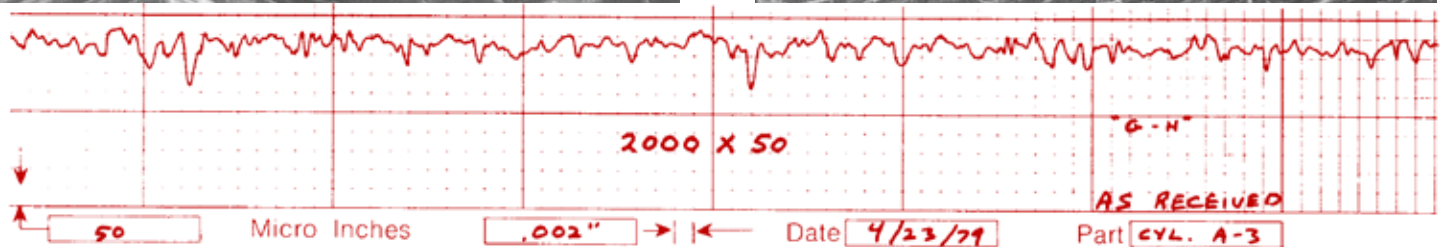
AS RECEIVED, PRODUCTION RIGID HONED, "G" photo at 1000x, "H" at 100x. Cross-hatch not uniform with "skips" in pattern. Torn, jagged, folded and smeared metal. Some of smeared metal loosely attached to surface. 20 to 25 μ " (.51 to .63 μ m) finish. #A-3 cylinder

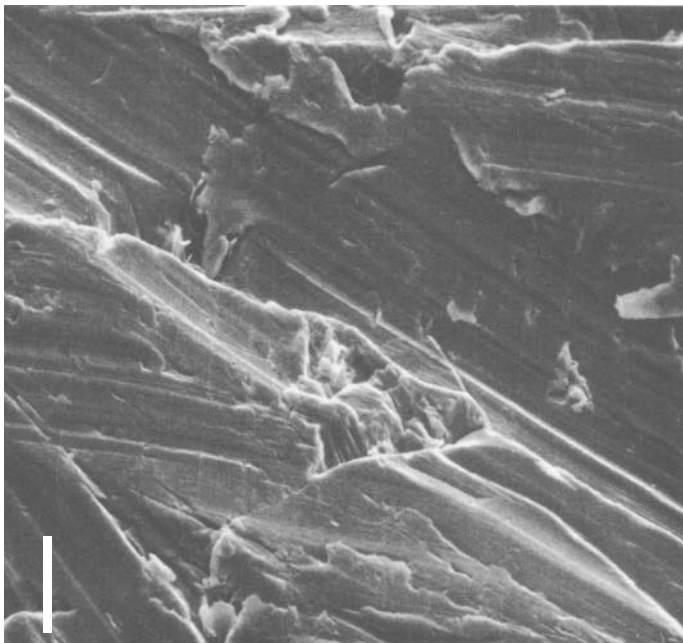
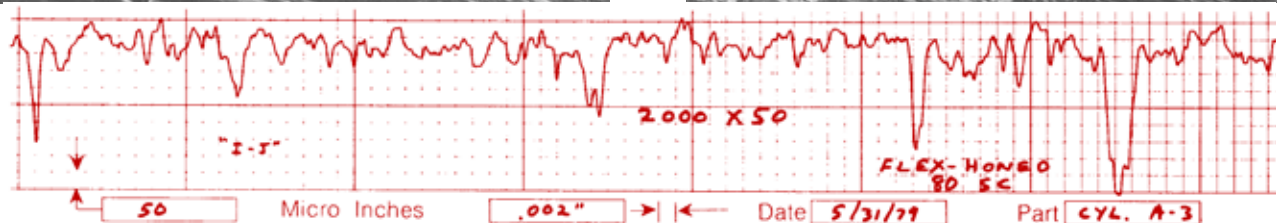
AFTER FLEX-HONE, 80 grit silicon carbide, "I" photo at 1000x, "J" at 100x. Uniform cross-hatch pattern. Surface has a very clean, open appearance with the torn, folded and smeared metal removed. Profiles somewhat peaky due to coarser grit size. 30 to 40 μ " (.76 to 1.02 μ m) finish. Section of #A-3 cylinder.

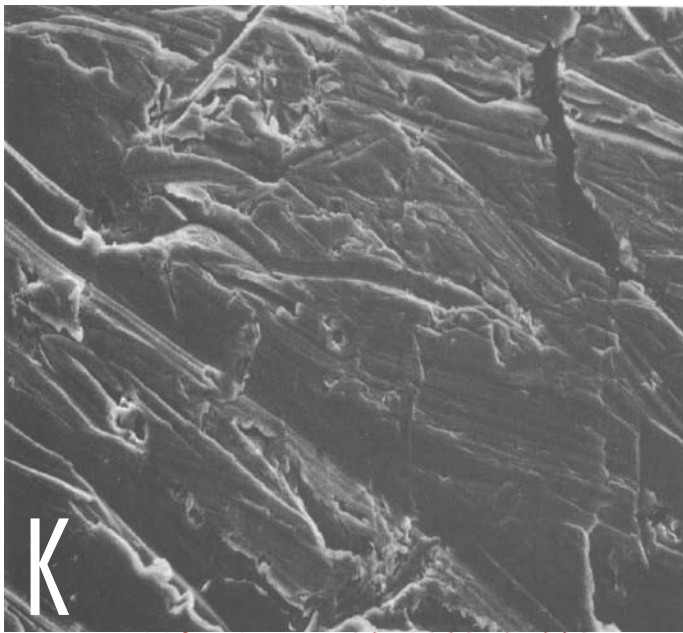
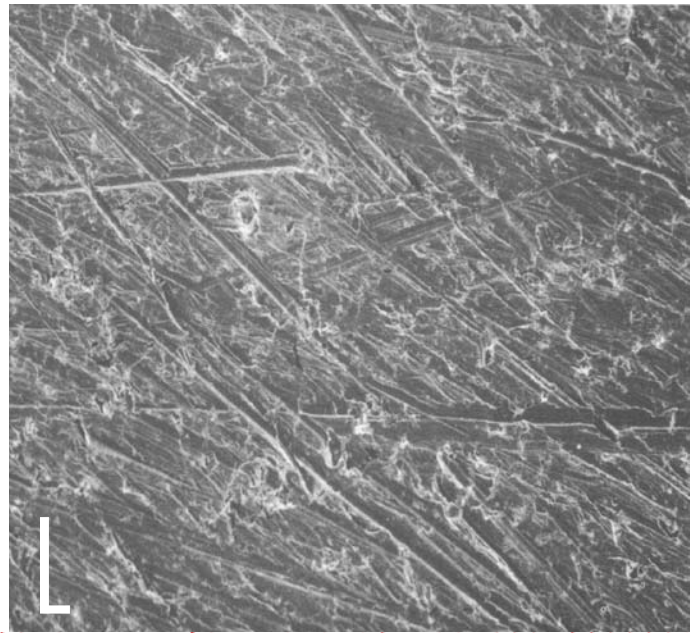
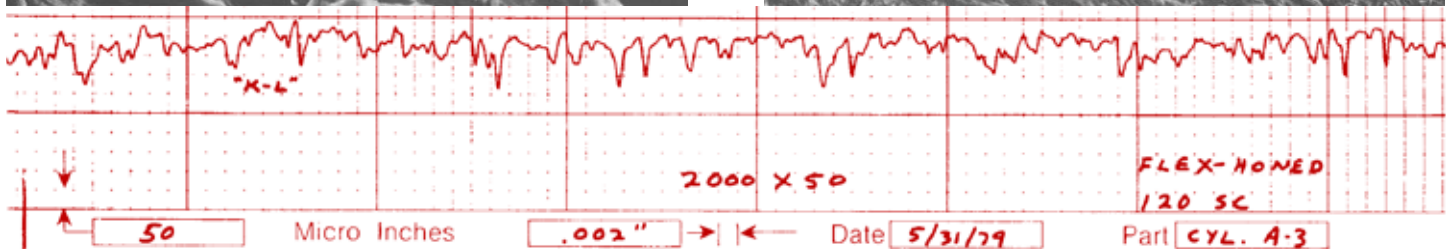
AFTER FLEX-HONE, 120 grit silicon carbide "K" photo at 1000X, "L" at 100X. Uniform cross-hatch pattern. Surface has clean open appearance with most of torn, folded, and smeared metal removed. Excellent semi - plateaued profile. 20 to 25 μ " (.51 to .63 μ m) finish. #A-3 cylinder.

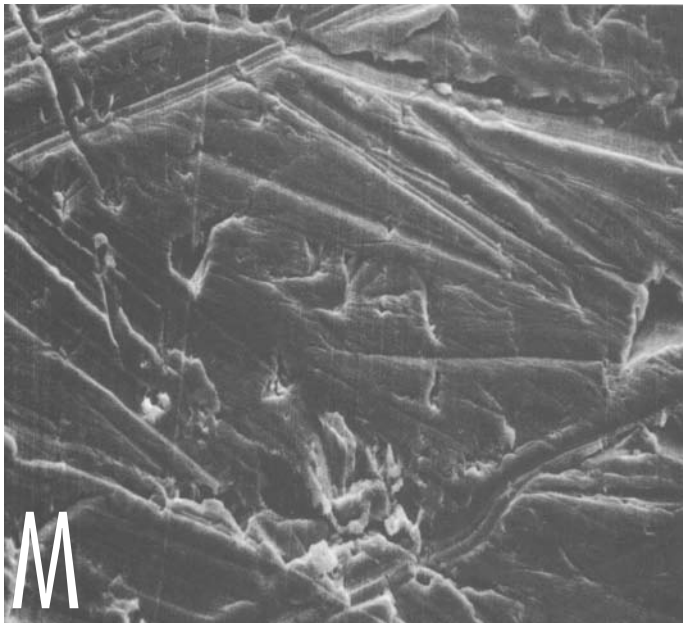
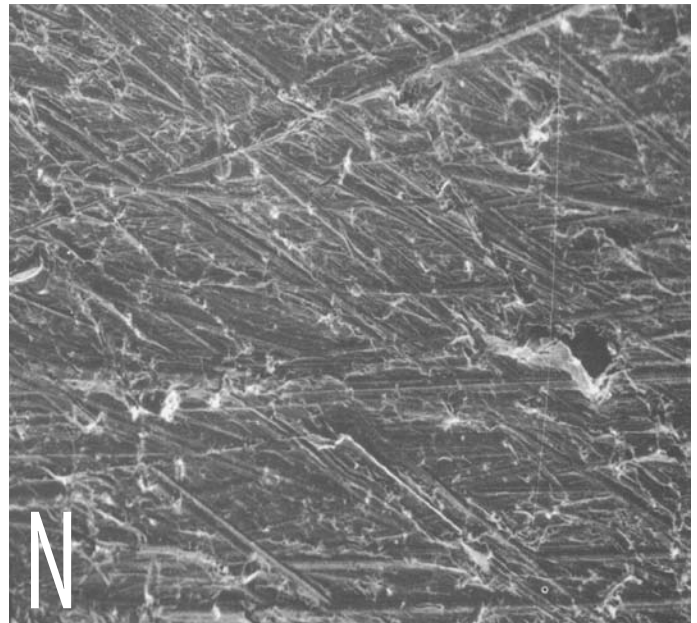
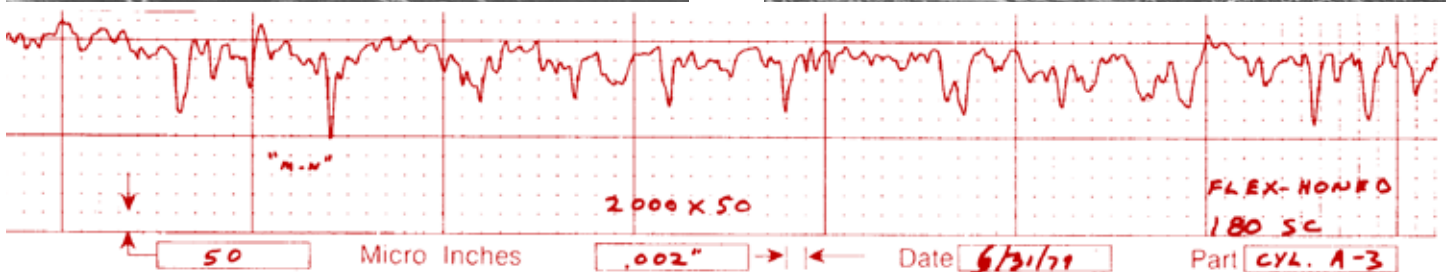
AFTER FLEX-HONE, 180 grit silicon carbide "M" photo at 1000X, "N" at 100X. Uniform cross-hatch finish. Surface has clean open appearance with most of torn, folded, and smeared metal removed. Excellent semi - plateaued profile. 20 to 25 μ " (.51 to .63 μ m) finish. #A-3 cylinder.

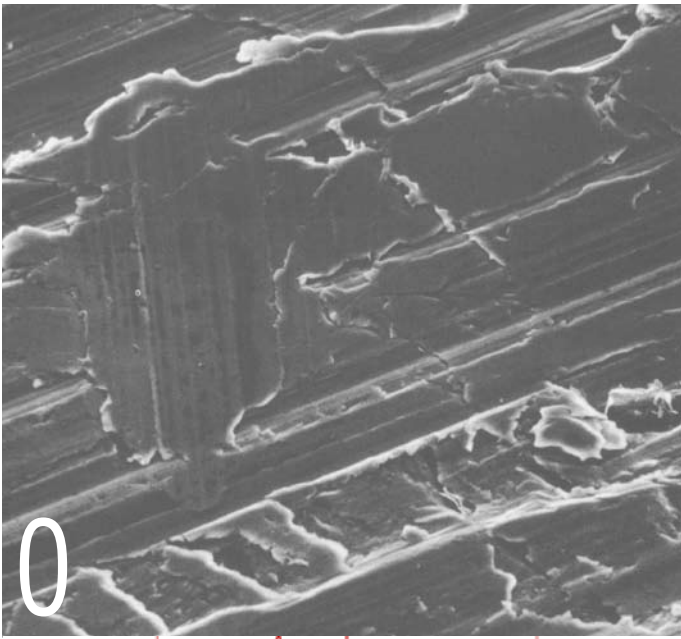
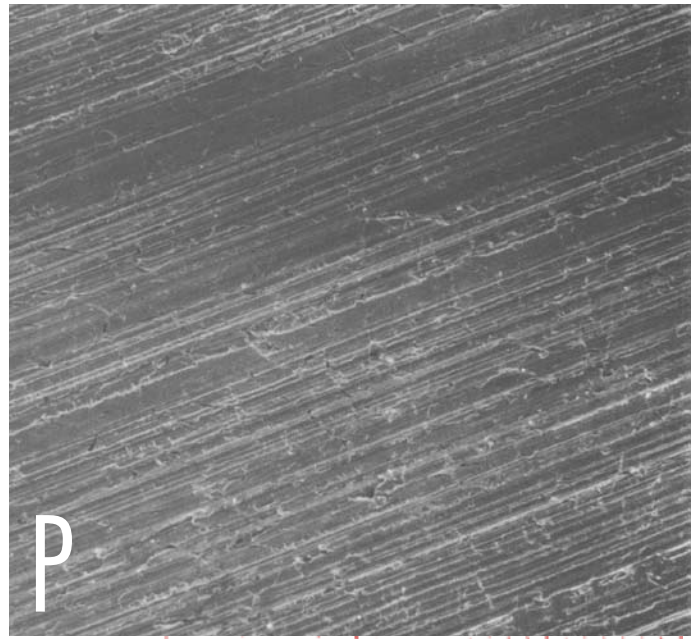
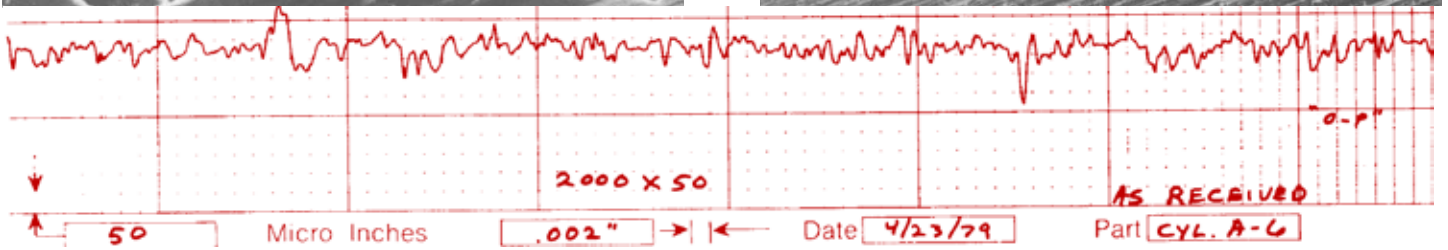
AS RECEIVED, PRODUCTION RIGID HONED, "O" photo at 1000X, "P" at 100X. Undirectional cut pattern from rigid hone operation. Peaky profile with typical saw tooth appearance. 20 to 25 μ " finish. #A-6 cylinder.

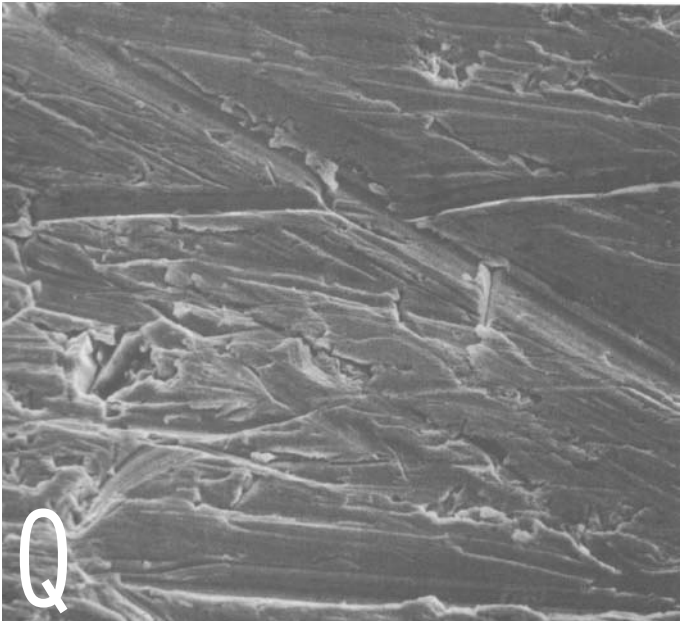
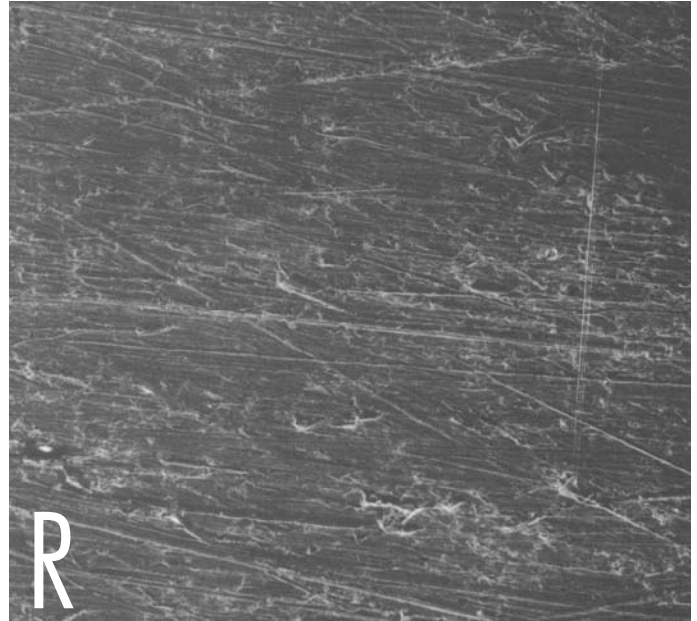
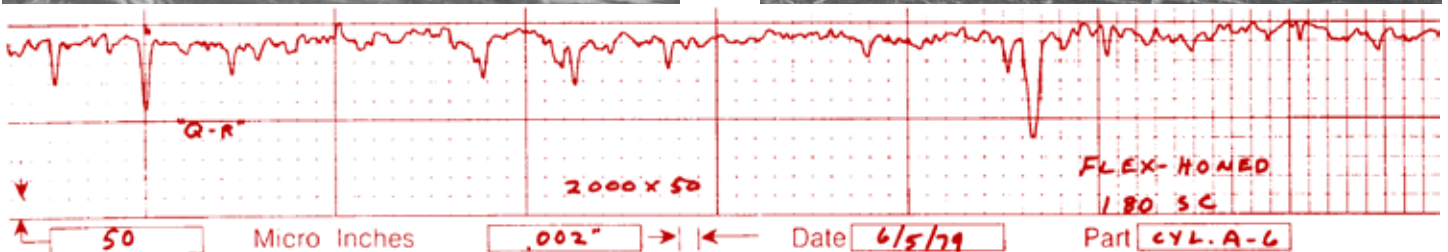
AFTER FLEX-HONE, 180 grit silicon carbide "Q" photo at 1000X, "R" at 100X. Uniform cross-hatch pattern. Surface has clean open appearance with most of torn, folded, and smeared metal removed. Excellent semi - plateaued profile. 20 to 25 μ " (.51 to .63 μ m) finish. #A-6 cylinder.

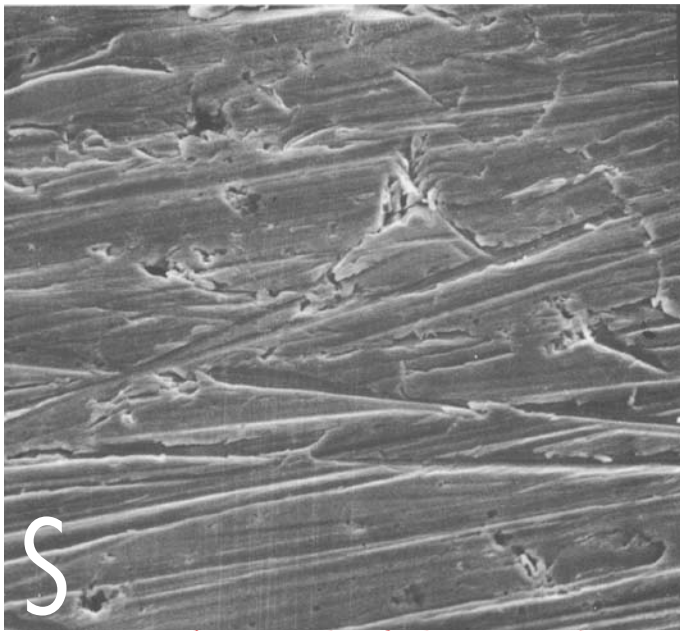
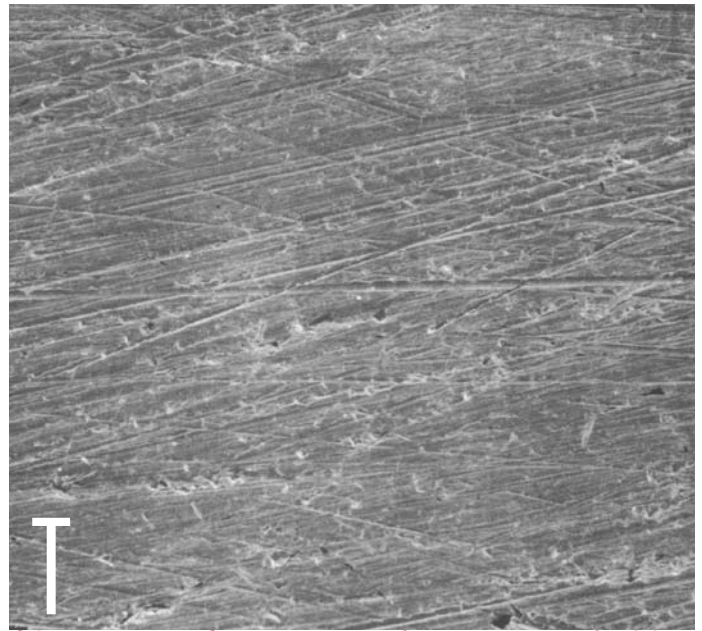
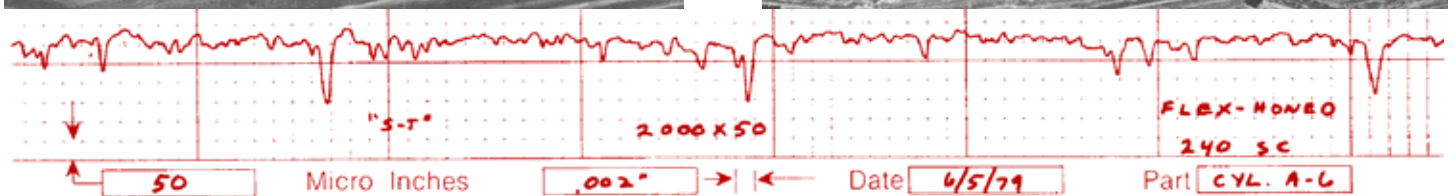
AFTER FLEX-HONE, 240 grit silicon carbide "S" photo at 1000X, "T" at 100X. More refined finish with uniform cross-hatch pattern. Surface has clean open appearance with most of torn, folded, and smeared metal removed. Excellent semi - plateaued profile. 12 to 18 μ " (.30 to .46 μ m) finish. Section of cylinder #A-6.

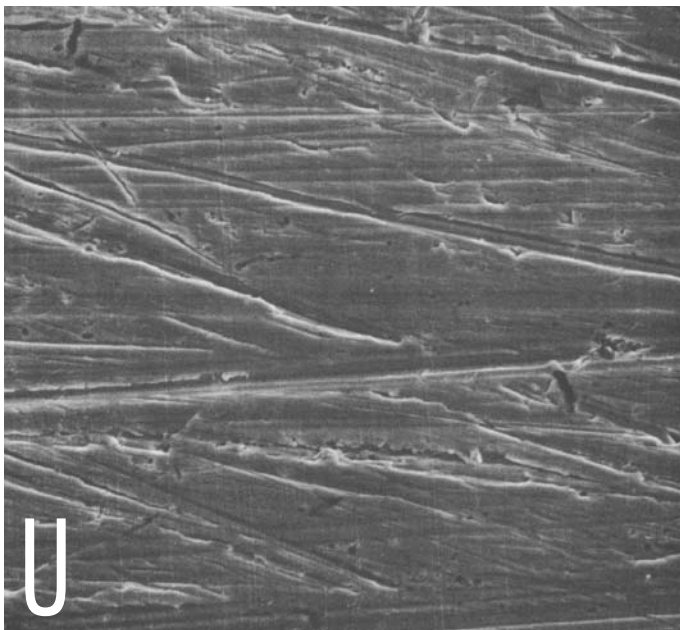
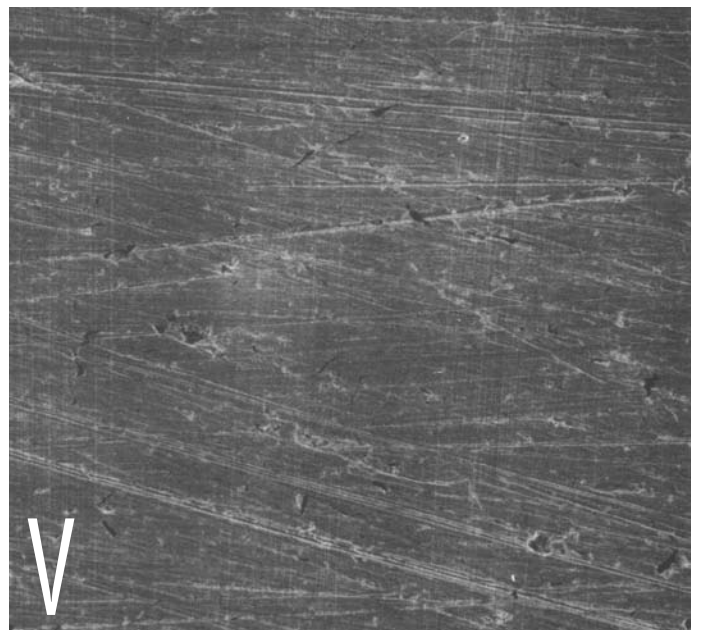
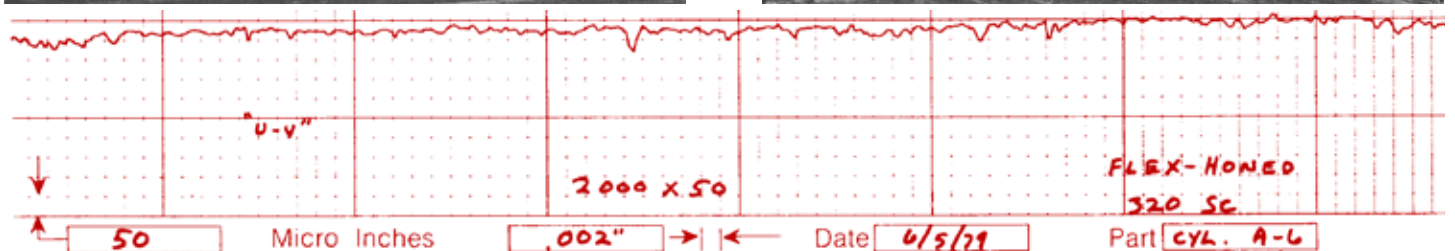
AFTER FLEX-HONE, 320 grit silicon carbide "U" photo at 1000X, "V" at 100X. More refined finish with uniform cross-hatch pattern. Surface has clean open appearance with most of torn, folded, and smeared metal removed. Excellent semi - plateaued profile. 7 to 10 μ " (.18 to .25 μ m) finish. Section of cylinder #A-6.

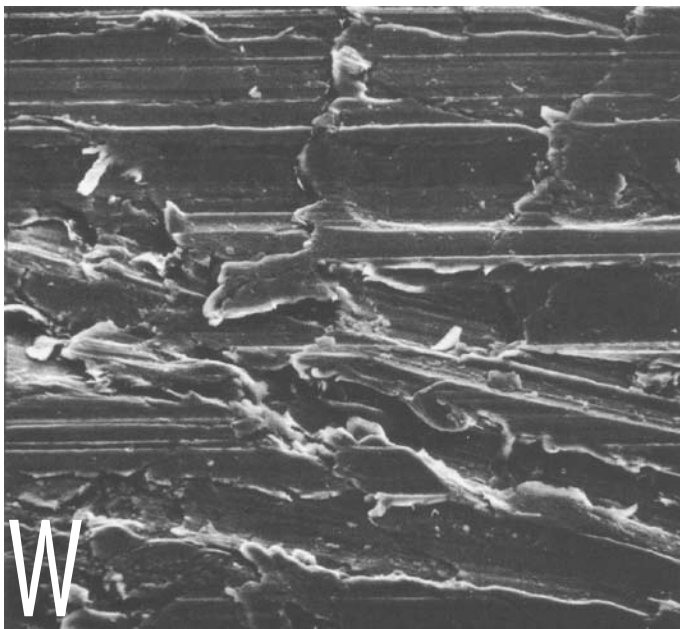
AS RECEIVED RIGID HONED BY FACTORY REWORK SECTION. "W" photo at 1000X. Cross-hatch has majority of cut in one direction. Smeared, torn, jagged and folded metal on surface. Smeared metal loosely attached to surface. Very peaky profile finish. 40 to 50 μ " (1.02-1.27 μ m) finish. Cylinder #B-1.

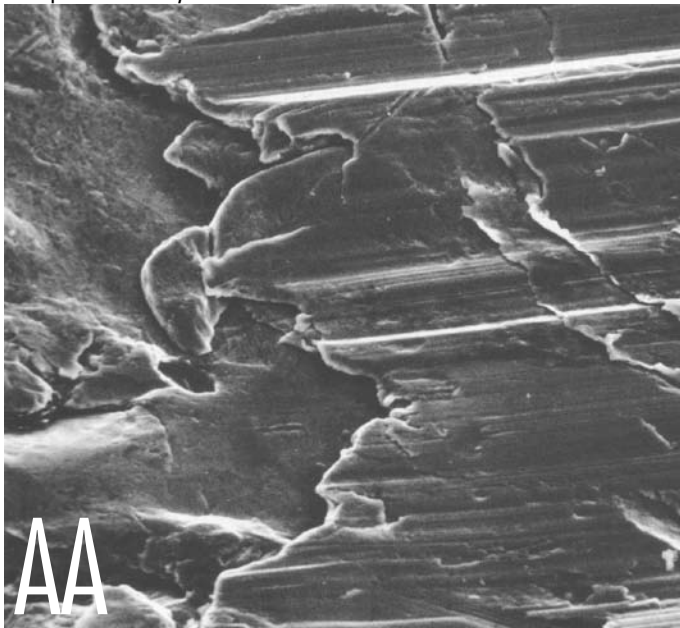
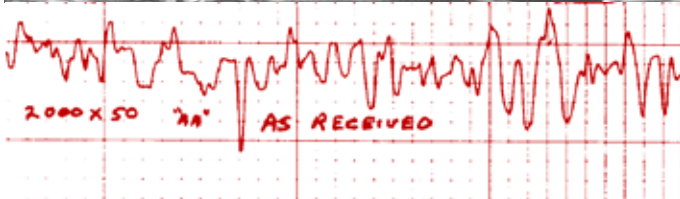
AS RECEIVED RIGID HONED BY FACTORY REWORK SECTION. "AA" photo at 1000X. Uniform cross-hatch pattern. Smeared, torn, and folded metal, smeared metal loosely attached. Very peaky profile.. 25 to 35 μ " (.63 to .89 μ m) finish. Cylinder #B-2.

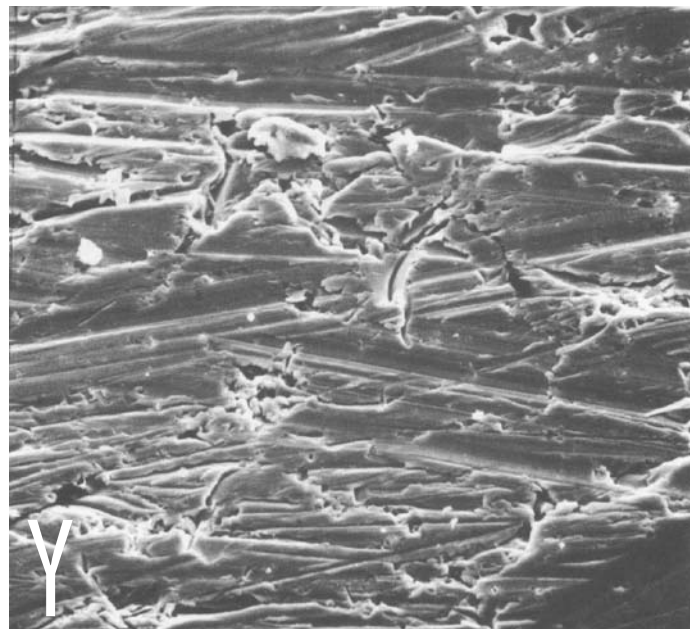
AFTER FLEX-HONE, 180 grit silicon carbide "Y" photo at 1000X. Uniform cross-hatch pattern. Surface has clean open appearance with most of torn, folded, and smeared metal removed. Excellent semi - plateaued profile. Small dust particles visible on surface in "Y" photo. 20 to 25 μ " (.51 to .63 μ m) finish. Cylinder #B-1.

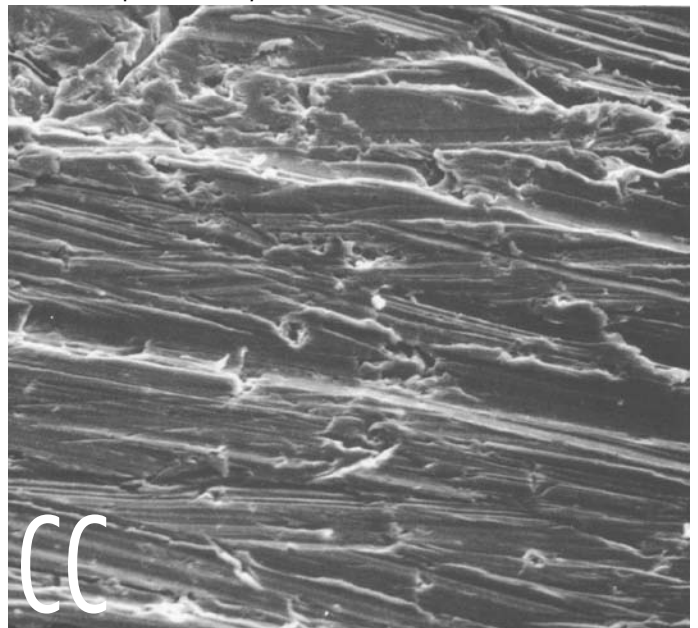
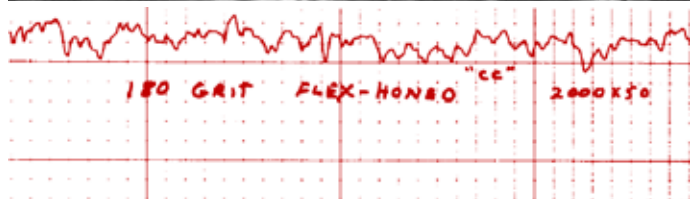
AFTER FLEX-HONE, 180 grit silicon carbide "CC" photo at 1000X. Uniform cross-hatch pattern. Surface has clean open appearance with most of torn, folded, and smeared metal removed. Excellent semi - plateaued profile. 20 to 25 μ " (.51 to .63 μ m) finish. Cylinder #B-2.

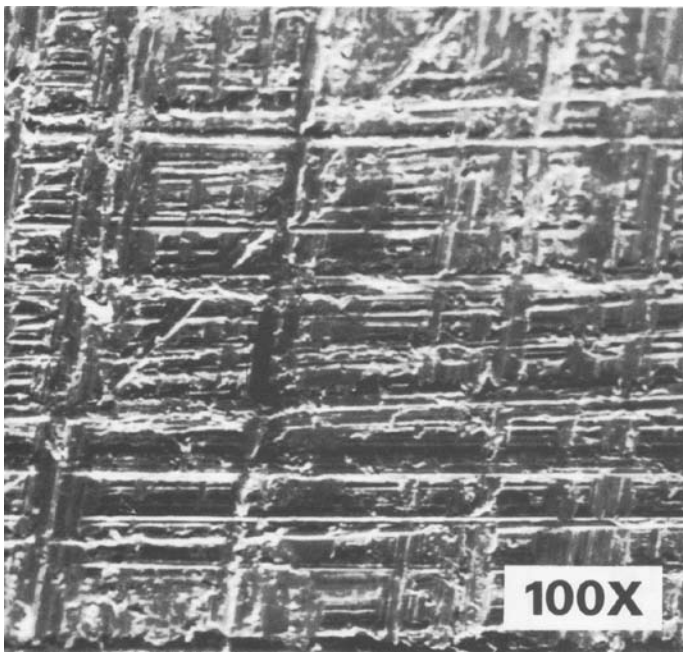
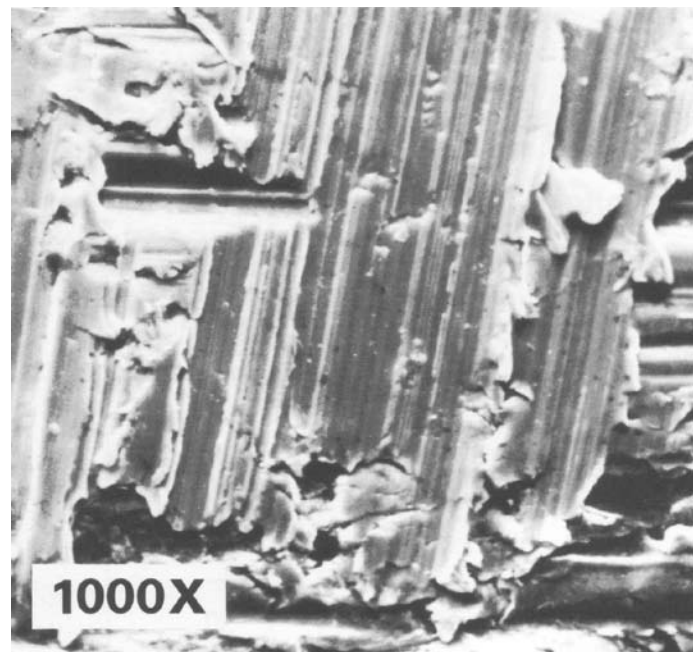
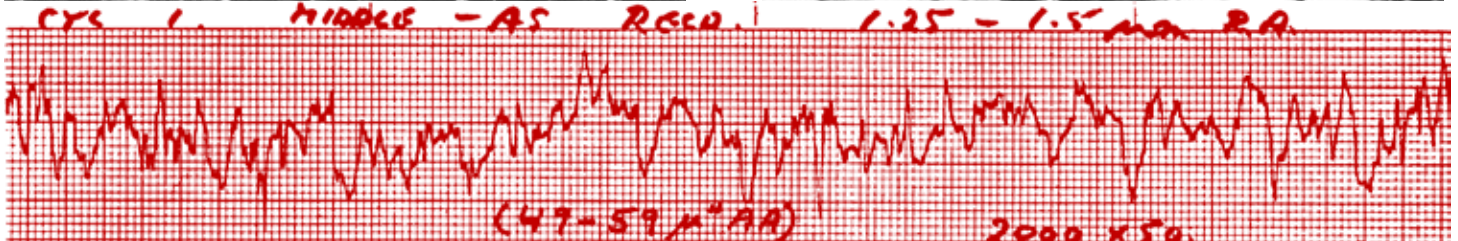
Cylinder (1). The above SEM photographs show the surface in the finished honed, As Received condition. Note the degree of smeared, torn and folded metal. The intersection of the cross hatch clearly shows a highly stressed condition. The profile of this cylinder shows a "peaky saw tooth" finish.

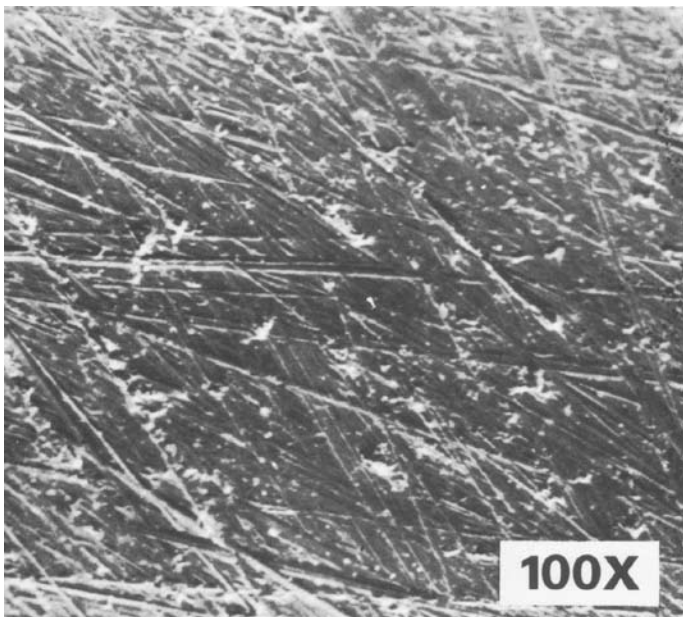
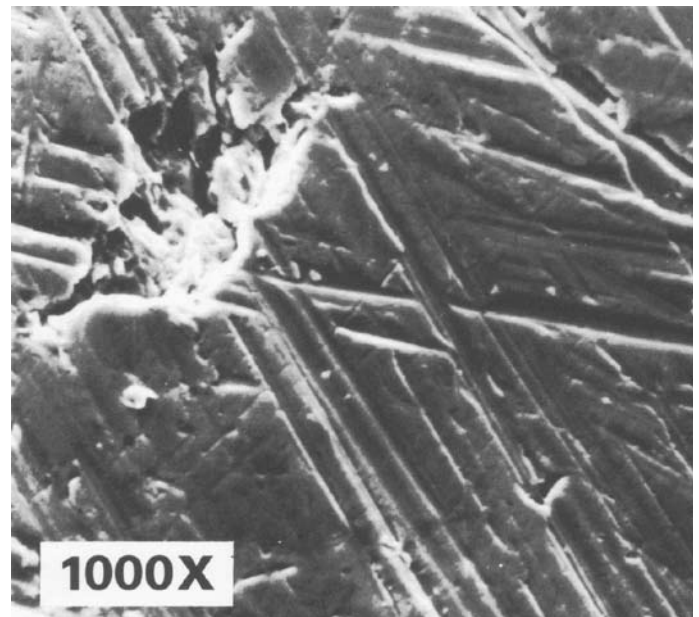
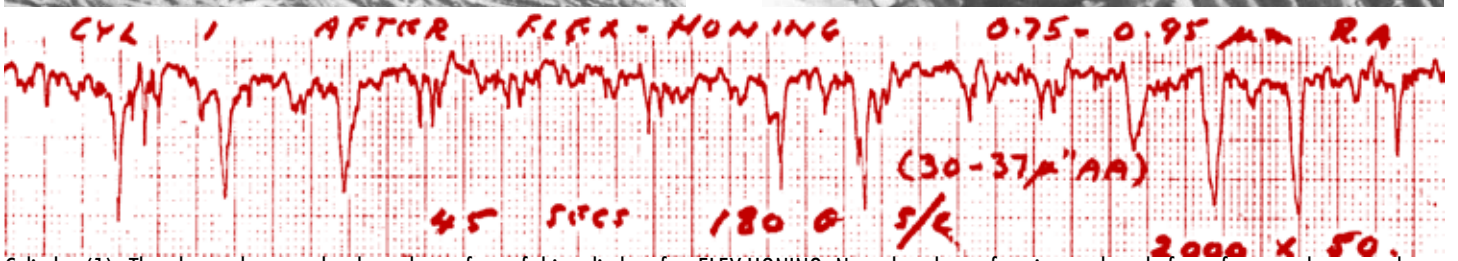
Cylinder (1). The above photographs show the surface of this cylinder after FLEX-HONING. Note that the surface is now largely free of smeared, torn and folded metal. Especially note that the intersections of the cross hatching have been stress relieved. The surface has also been "opened up" in that the graphite grains on or close to the surface have been revealed rather than smeared over. The profile of the surface shows quite clearly that FLEX-HONING has provided an excellent "plateau".
