A STUDY OF A CYLINDER WALL MICRO-STRUCTURE

BRUSH RESEARCH MANUFACTURING CO., INC.

EVOLUTION OF A STUDY IN THE MICRO-FINISHING OF CYLINDER WALLS

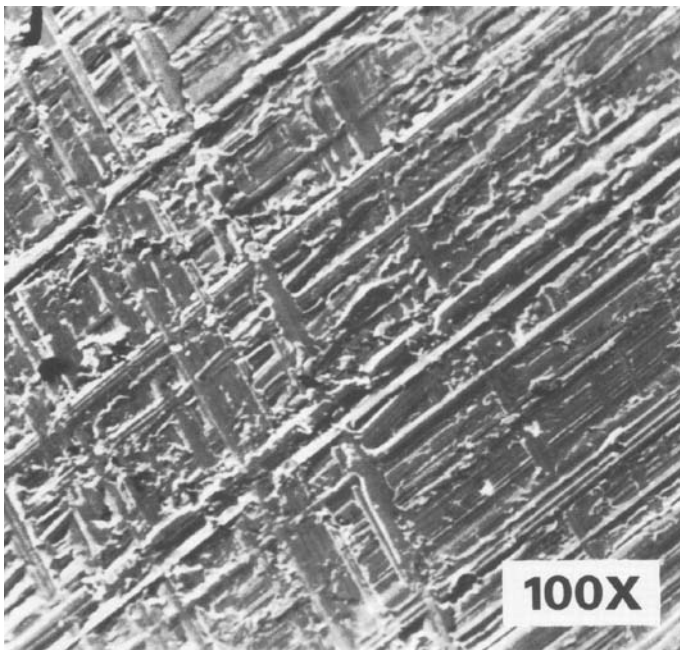
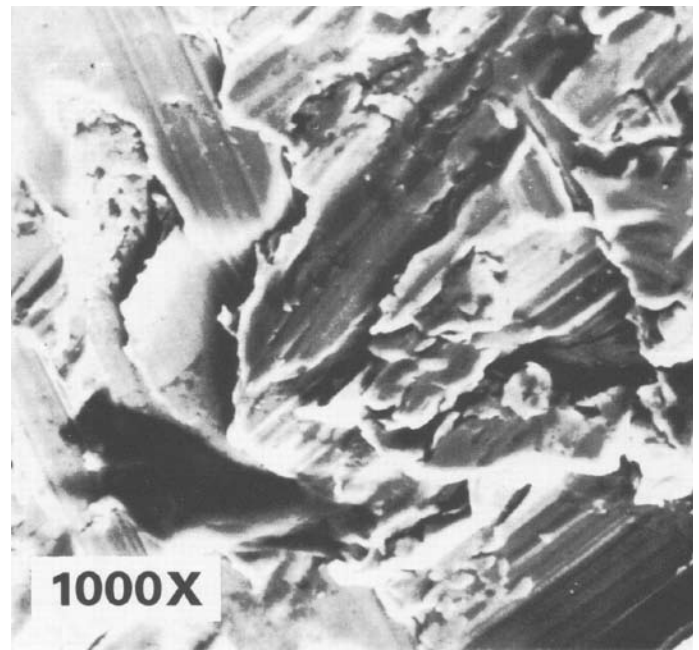
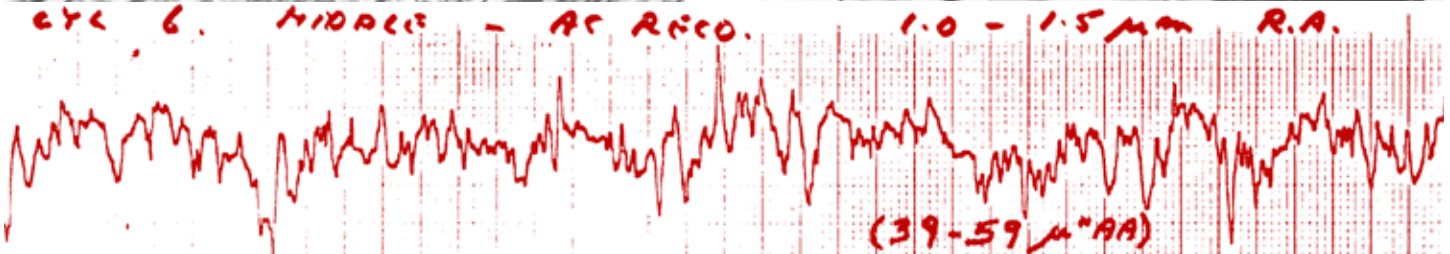
Cylinder (6). The above SEM photographs show the surface in the rough honed, As Received condition. Note the high degree of smeared, torn and folded metal. Note also the high stress areas at the cross hatch intersections. The profile of the surface is "peaky raw tooth."

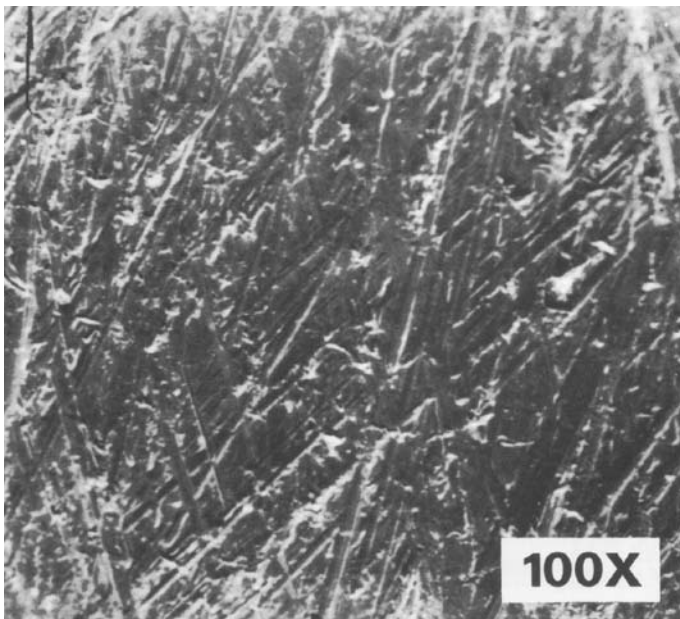
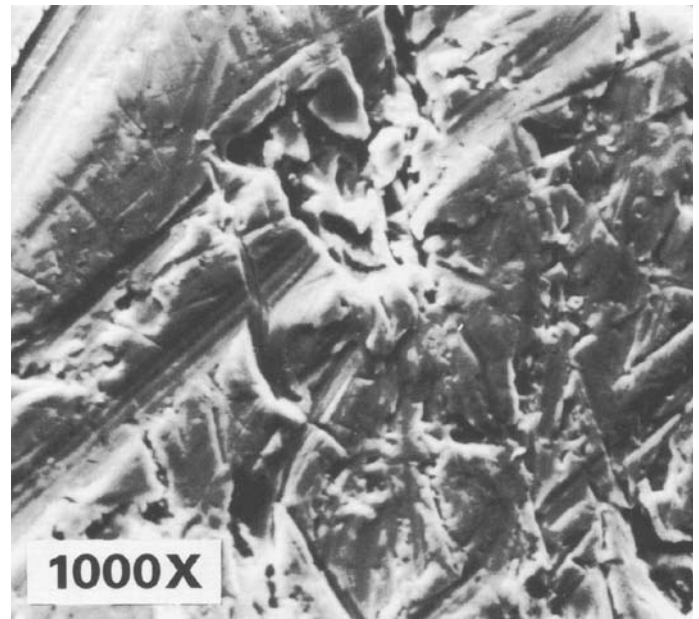
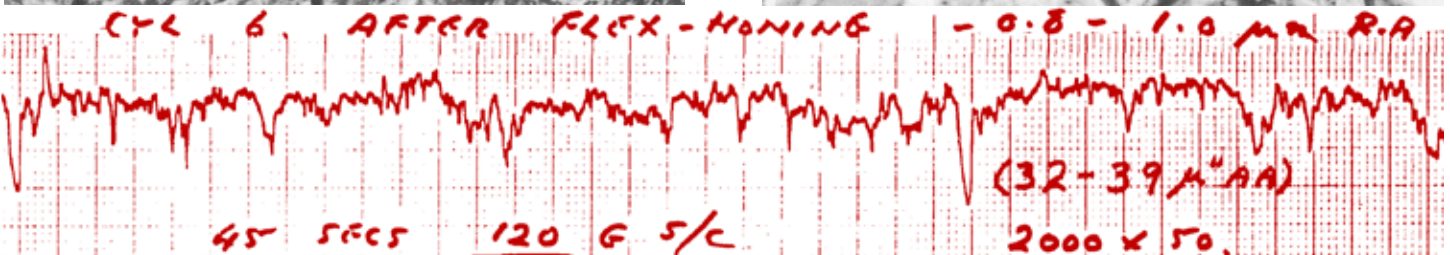
Cylinder (6). The above SEM photographs show the surface after FLEX-HONING. Note that the surface is now largely free of smeared, torn, and folded metal. Slightly less so than Cylinder (1) after FLEX-HONING. Cylinder (6) was FLEX-HONED with I 20 grit silicone carbide as opposed to 180 grit on Cylinder (1). Again note that the surface has been "opened up" to expose the graphite grains. The profile after FLEX-HONING shows a good "semi-plateau."

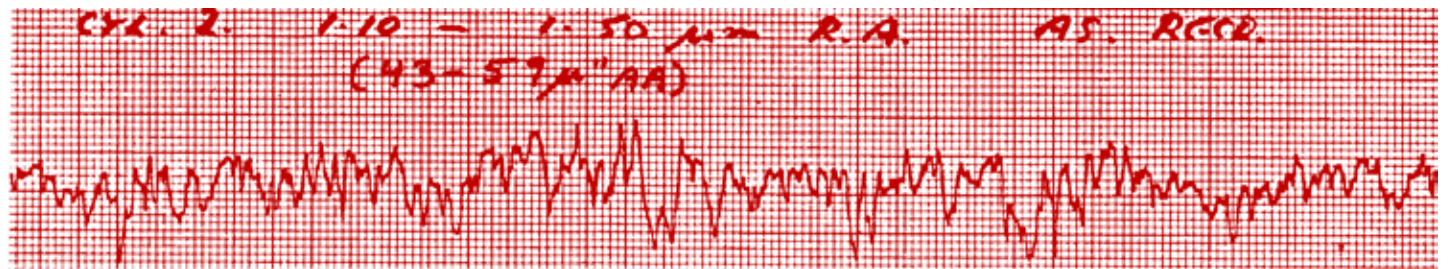
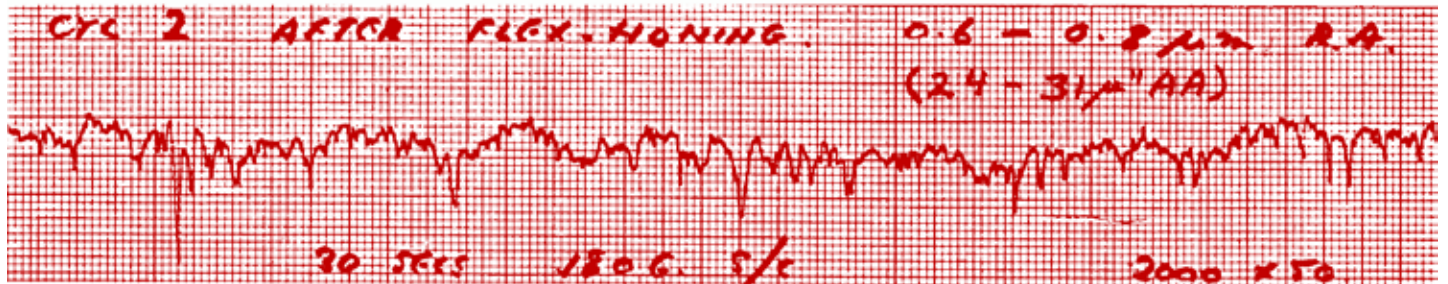
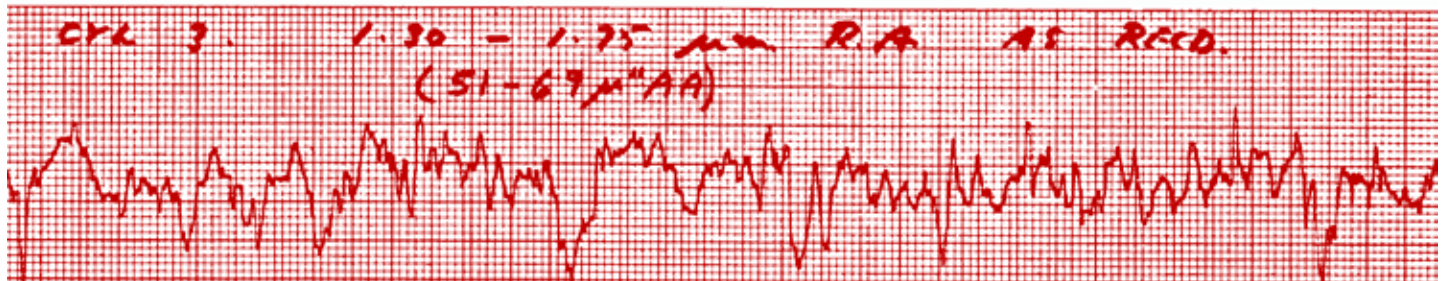
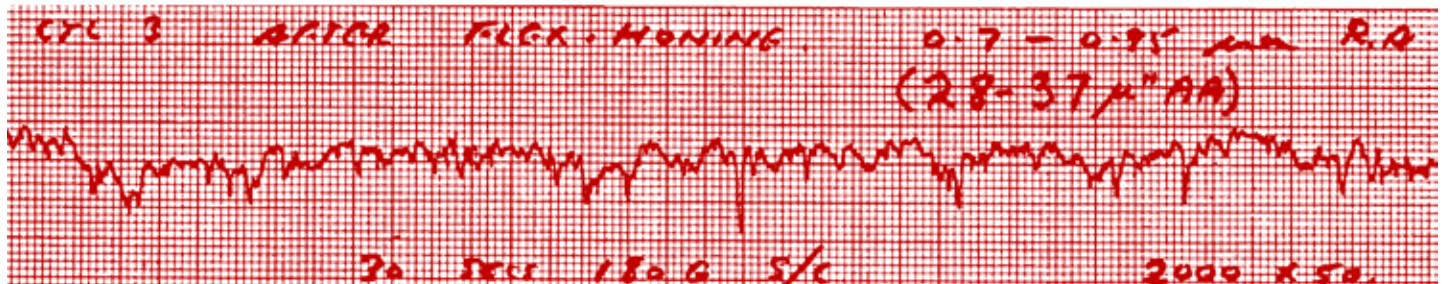
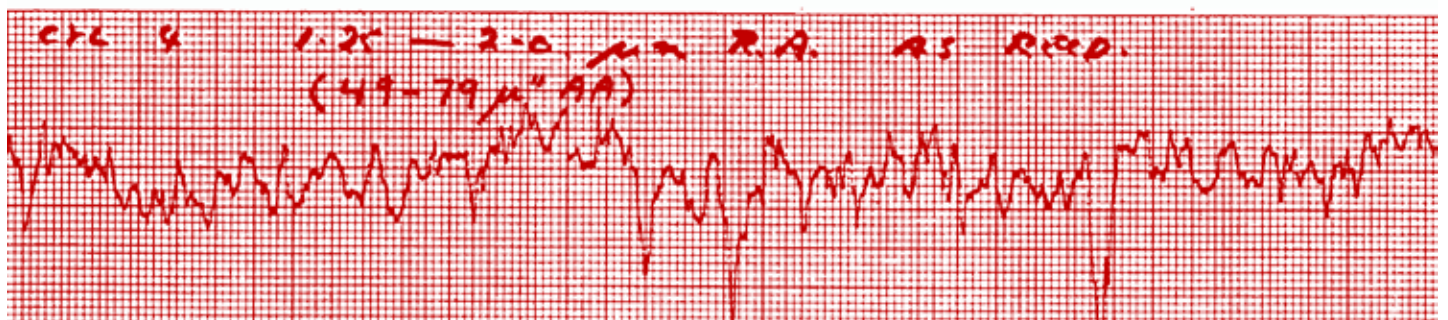
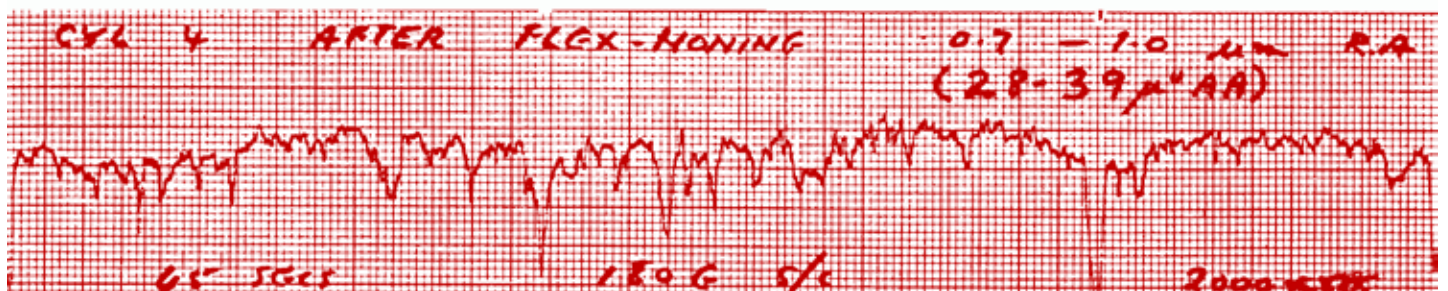
BEFORE AND AFTER PROFILES OF CYLINDER LINERS 2, 3, 4, 5, 7, & 8 OF TEST PART ONE:

Please note the result of the Flex-Honing on the profiles of the above cylinders. In every case, Flex-Honing has resulted in a "plateau" or "semi-plateau" profile. Note also how consistent the surface finishes are after Flex-Honing.

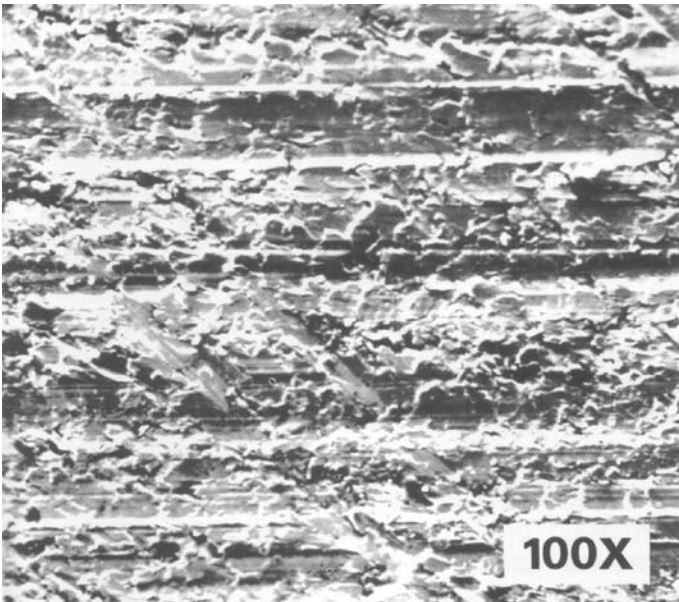
Cylinder (1). The above SEM photographs show the surface in the As Received condition, i.e. Rough Honed to size by standard production rigid hones. Note that the surface is of smeared, torn and folded metal and that the graphite grains are substantially smeared over. The profile of the surface, as is to be expected at this stage of production, is very "peaky saw tooth."

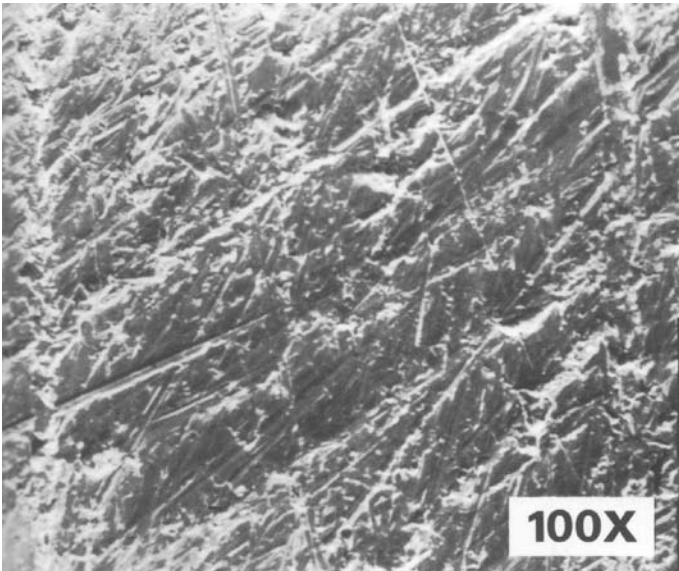
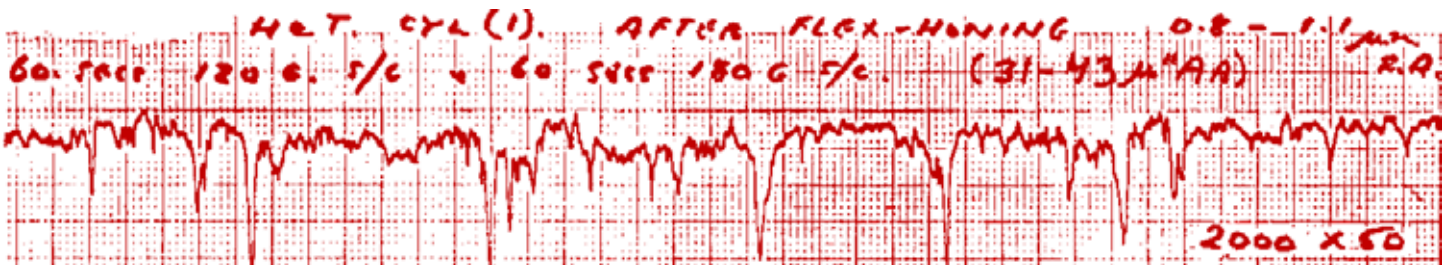
Cylinder (1). The above SEM photographs show the surface after FLEX-HONING. Note that most of the smeared, torn and folded metal has been removed and that the surface has been "opened up" to reveal the graphite grains on or close to the surface. The profile shows quite clearly how the FLEX-HONE has refined the rough honed surface to an excellent Plateaued finish.

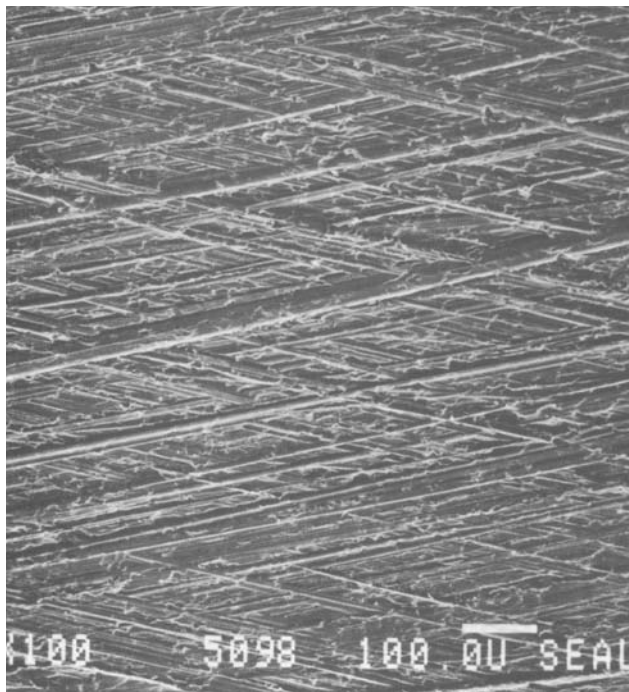
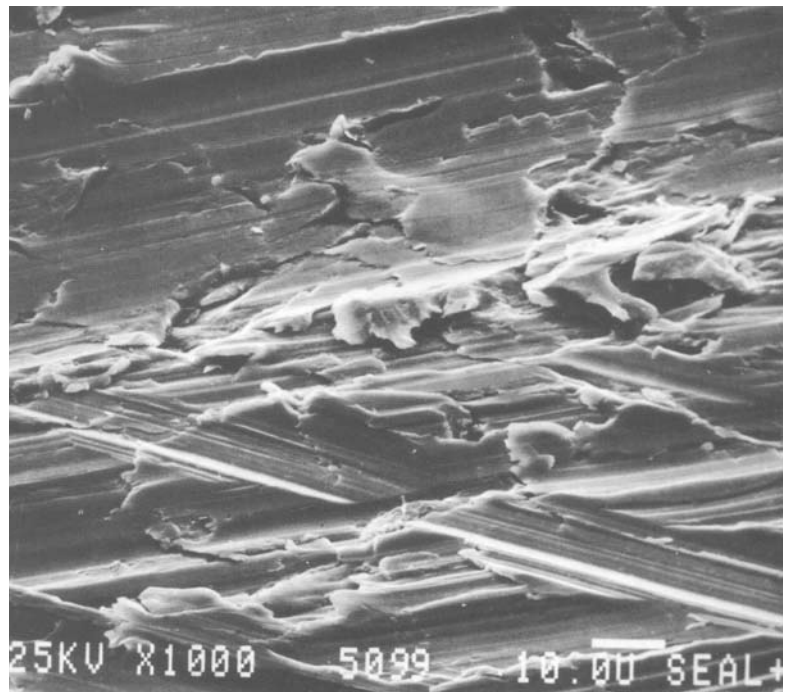
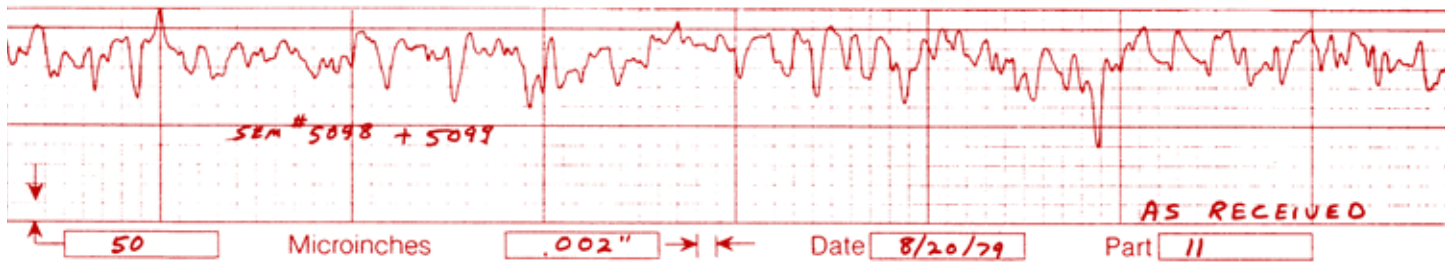
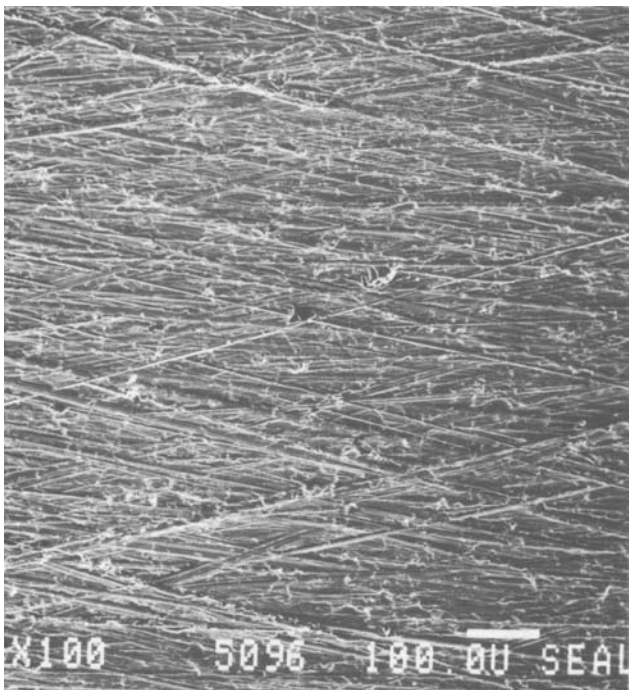
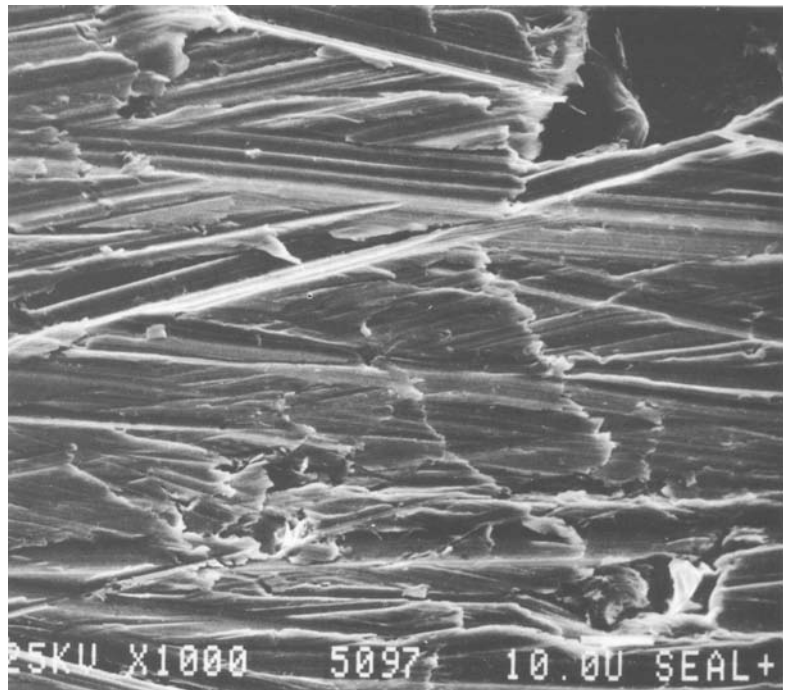
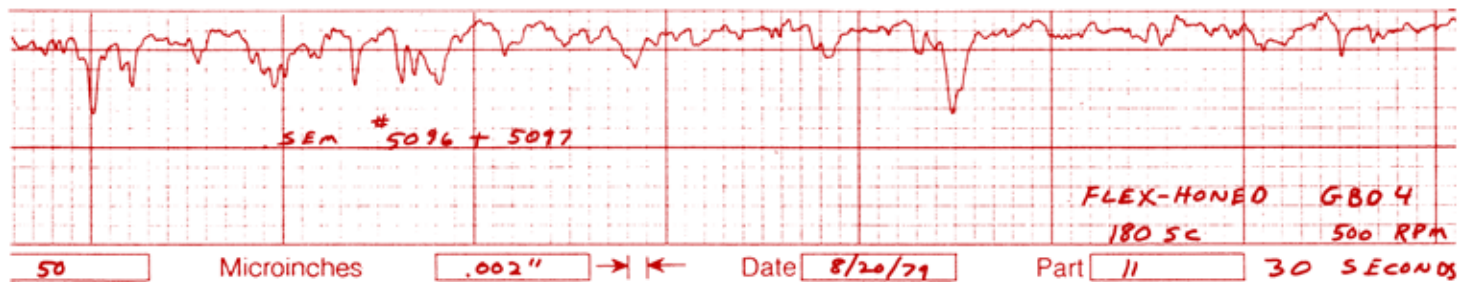
The As Received condition was typically a peaky saw tooth profile. After being Flex-Honed the surface finish was refined to a consistent plateaued or semi-plateaued profile. The SEM photographs show that the smeared, folded and torn metal have been removed leaving an open "clean" surface for rapid ring seating and the elimination of scuffing problems.

Our decision to Flex-Hone the above cylinders for 15 additional seconds was based on the SEM photos of the first two cylinders. The two cylinders Flex-Honed for 30 seconds still had traces of smeared metal on the surface, which we feel was removed with the additional 15 seconds.

Upon receipt of the 12 cylinders from Waukesha we made Surfanalyzer profiles of all bores. We decided to use a GBD - 4" 180 grit Flex-Hone with Flex-Hone Oil as a lubricant. We used a 500 RPM hand drill and stroked the Flex-Hone in the bore to produce a 25 to 30° cross-hatch angle. We cut off the top 1" of cylinders # 11 and 12 for SEM photos in the As Received condition. We Flex-Honed, for 30 seconds, the lower portion of #11 and 12 and then cut a 1" square piece out for SEM photos. After examining the SEM photographs and profiles we decided to Flex-Hone the remaining 10 cylinders for 45 seconds each. Profiles were then taken of all bores for final comparison. We feel you will agree with us that the Flex-Hone Process has improved both final condition of the surface and the surface profile.
